## **INVESTIGATION REPORT**

**DERAILMENT OF TRAIN 4132 OF THE EAV RAILWAY  
UNDERTAKING ON THE LINE NAPLES – TORRE ANNUNZIATA  
POGGIOMARINO, AT THE POMPEI SANTUARIO STATION, ON  
07/11/2022**

(ERAIL IDENTIFIER: IT-10335)

10 November 2023

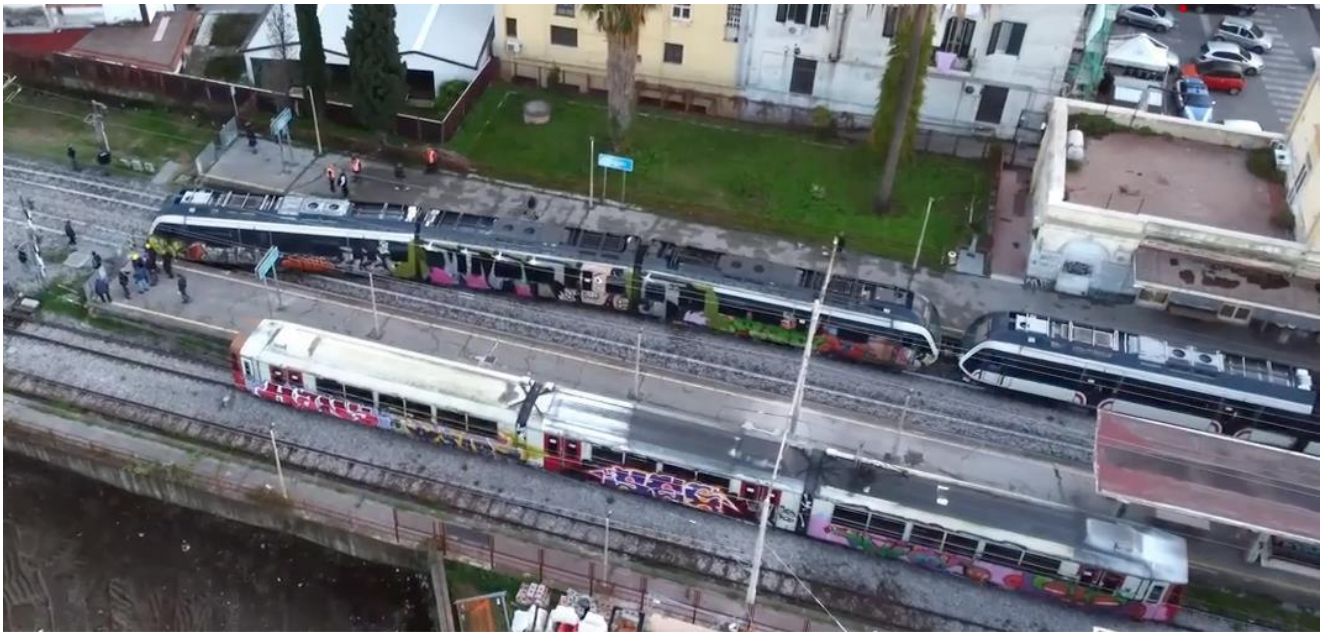
In particular, train no.4132, consisting of the METROSTAR type ETRs no. 223 and no. 208, coming from Poggiomarino and bound for Naples, derailed behind the switch no.4 of the two rear bogies of the ETR 208.

Figure 1 - Static position of the train after the accident (*source: web*).

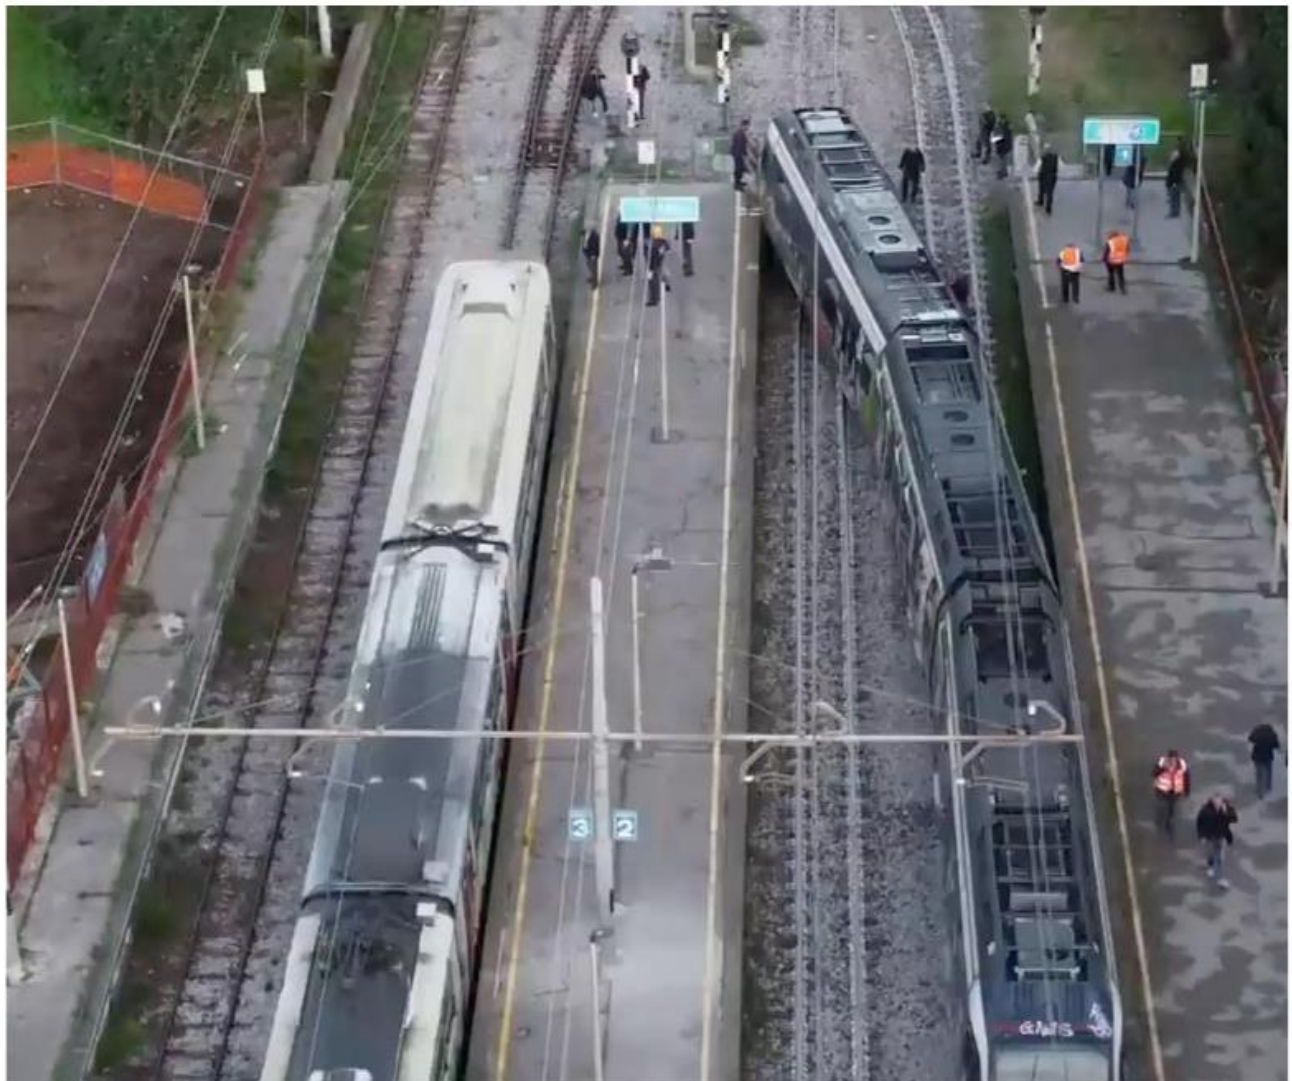
Figure 2 - Static position of the train after the accident (source: web).

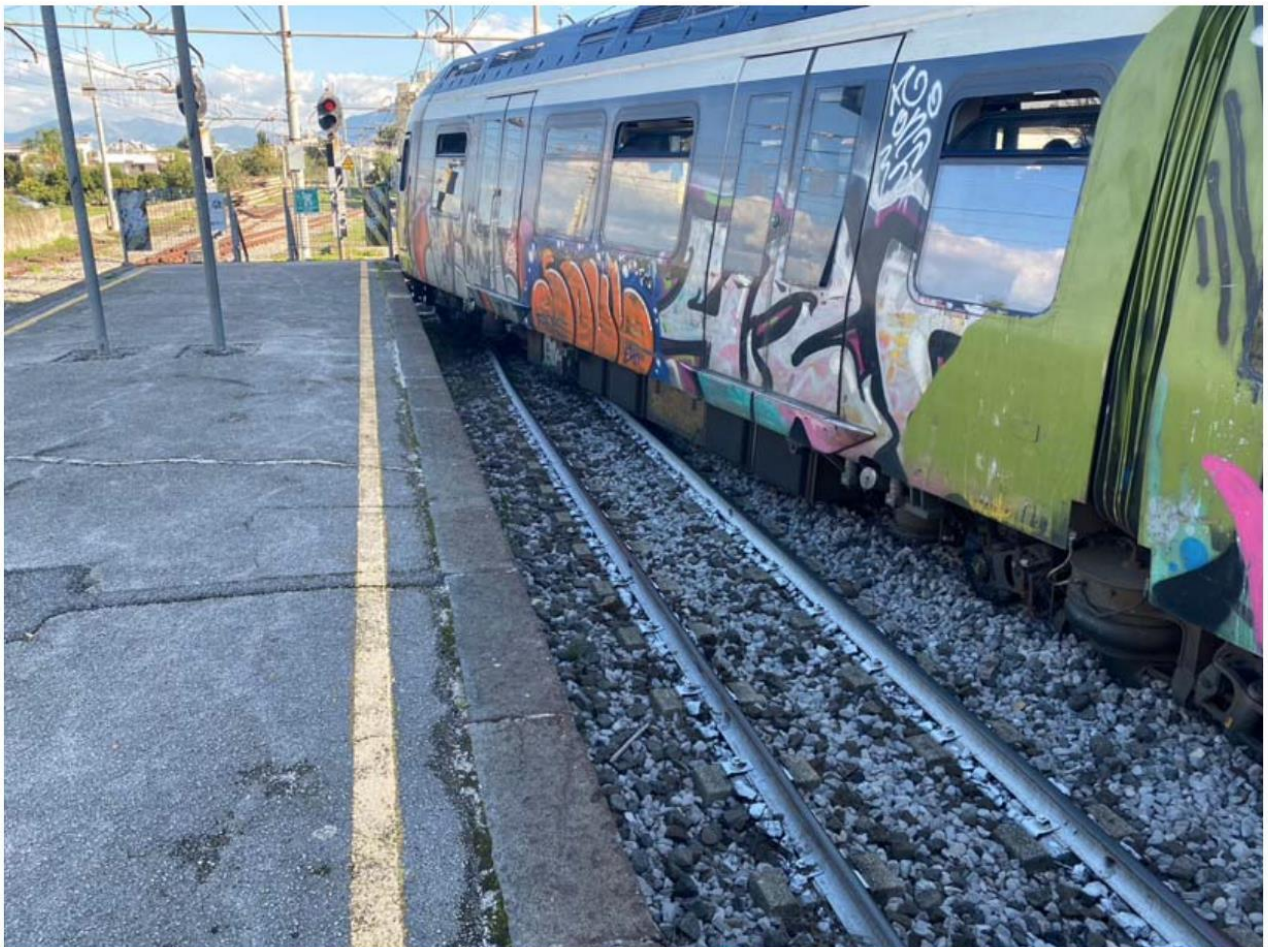
Figure 9 - ETR 208 after derailment (source: EAV).

In particular, the last two bogeys, number 4 and number 5, of the ETR 208 rear electric train derailed from track 1, with truck no.4 routing on track 2.

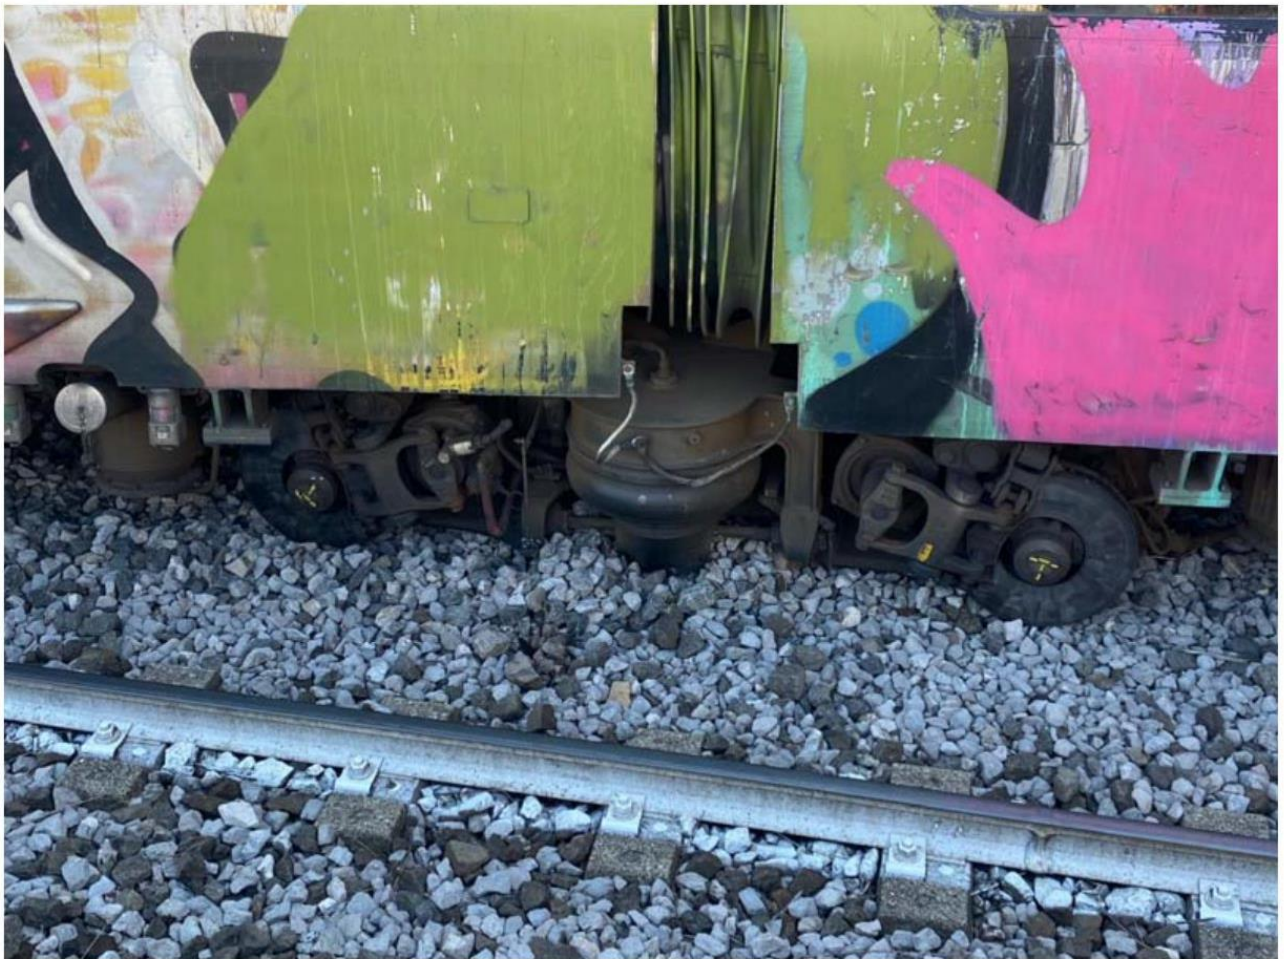
With regard to rolling stock, the derailment took place behind the switch no.4, and affected the two rear bogeys of ETR 208. The general finding of the damage caused by the derailment was carried out by visual investigation, downstream of the restitution of rolling stock by the judicial activities and is summarised in Table 1.

Figure 10 - Bogie no.5 of the ETR 208 after derailment (source: EAV).

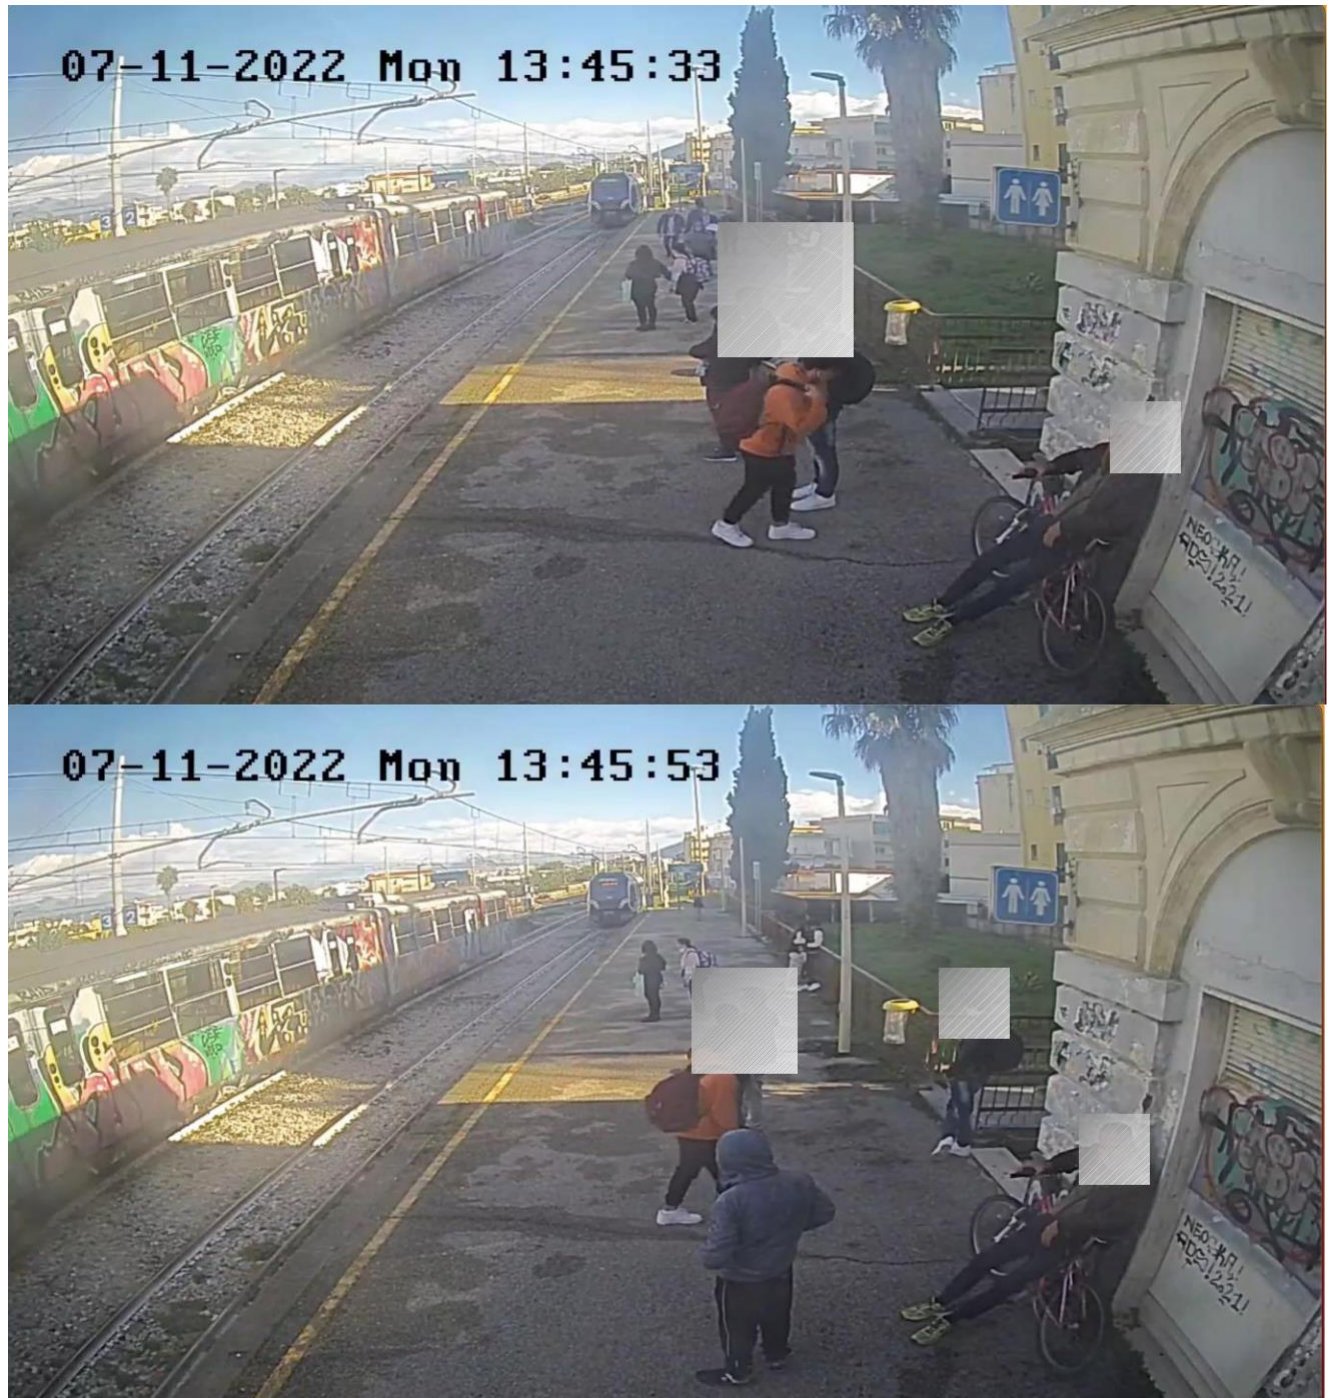
Moreover, this reconstruction of the facts is confirmed video surveillance camera footage of the Pompei Santuario station. The following Figure 15 shows the still images of the moment at which train 4132 stopped at the beginning of the platform on track 1 and the moment at which it left again. The analysis of these still images also shows that train 4132 remained stationary at the end of the passenger platform of track 1 on the Poggiomarino side for 20s, from 1:53 p.m. to 1:45:45:33 p.m. The difference in the time from the tachograph zones of ETR 223 and 208 is due to the fact that the time indicated by the camera differs by +16s from that of the tachograph zone of ETR 223.

Figure 15 - Still images taken from the video camera footage of the video surveillance circuit at the station of Pompei Santuario relating to the instant when train 4132 stopped at the height of the beginning of the platform on track 1 and the instant when it left again (elaboration: DiGiFeMa).

È It is thus confirmed that train 4132 then remained stationary for 20s with the front at the height of the Poggiomarino-side end of the passenger platform of track 1. In that position, the train, whose overall length is about 80 m, had not yet fully passed the switch no.4 which had been positioned, using the emergency keys, in a deviated configuration precisely to allow the arrival at track 1. The extremity of switch 4 was likely located between the two bogeys of the locomotive M2 of the ETR 208. During this time, switch no.4 was brought back to its normal configuration without checking that the train had passed completely over the switch, so that at the departure the CV6 and CV4 bogeys at the rear of ETR 208 derailed, with the CV6 bogey being routed on track 2, while the CV4 bogey was out of way between tracks 1 and 2.

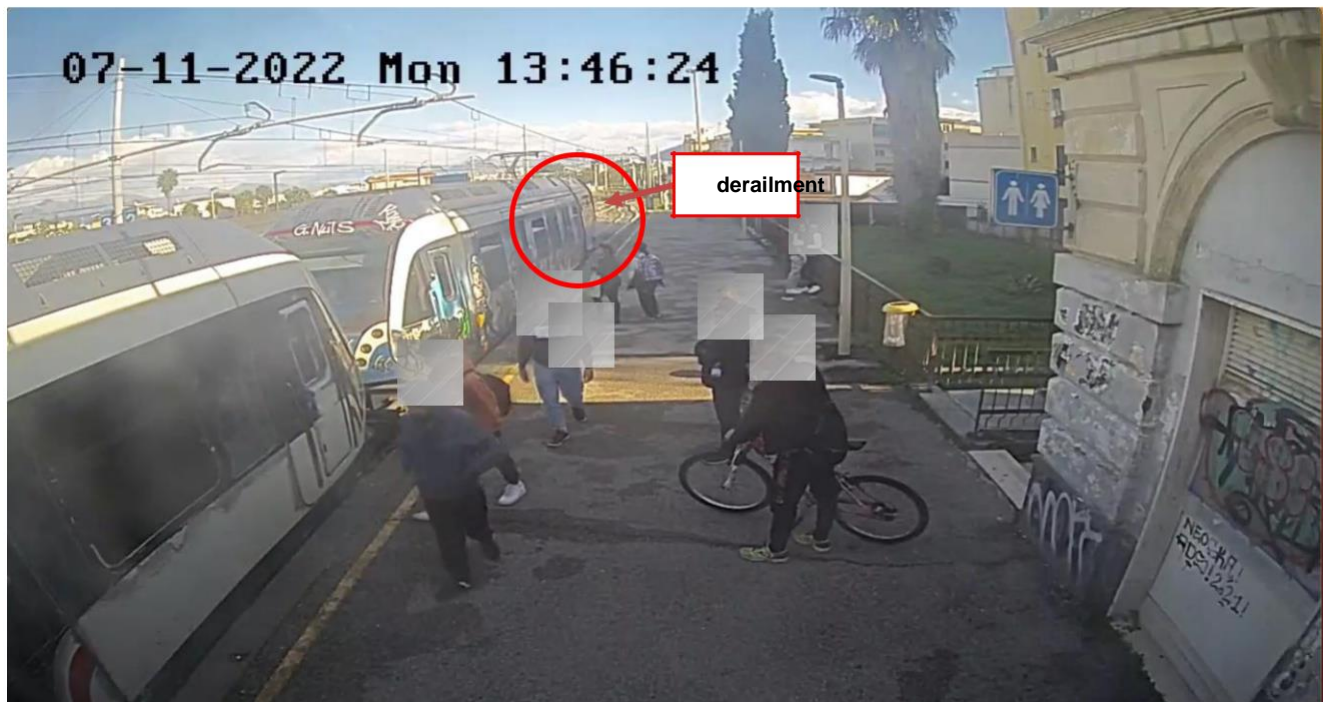
On the other hand, Figure 16 shows the still image of the moment 1:46:24 p.m. when train 4132 completed the parking manoeuvre at the platform of track 1. This time is also consistent with the time obtained from the tachograph zones at less than a time shifting of 16s.

Figure 16- Still images taken from the video camera footage of the video surveillance circuit at the station of Pompei Santuario relating to the instant when train 4132 completed its manoeuvre of parking at the platform on track 1 (*elaboration: DiGiFeMa*).

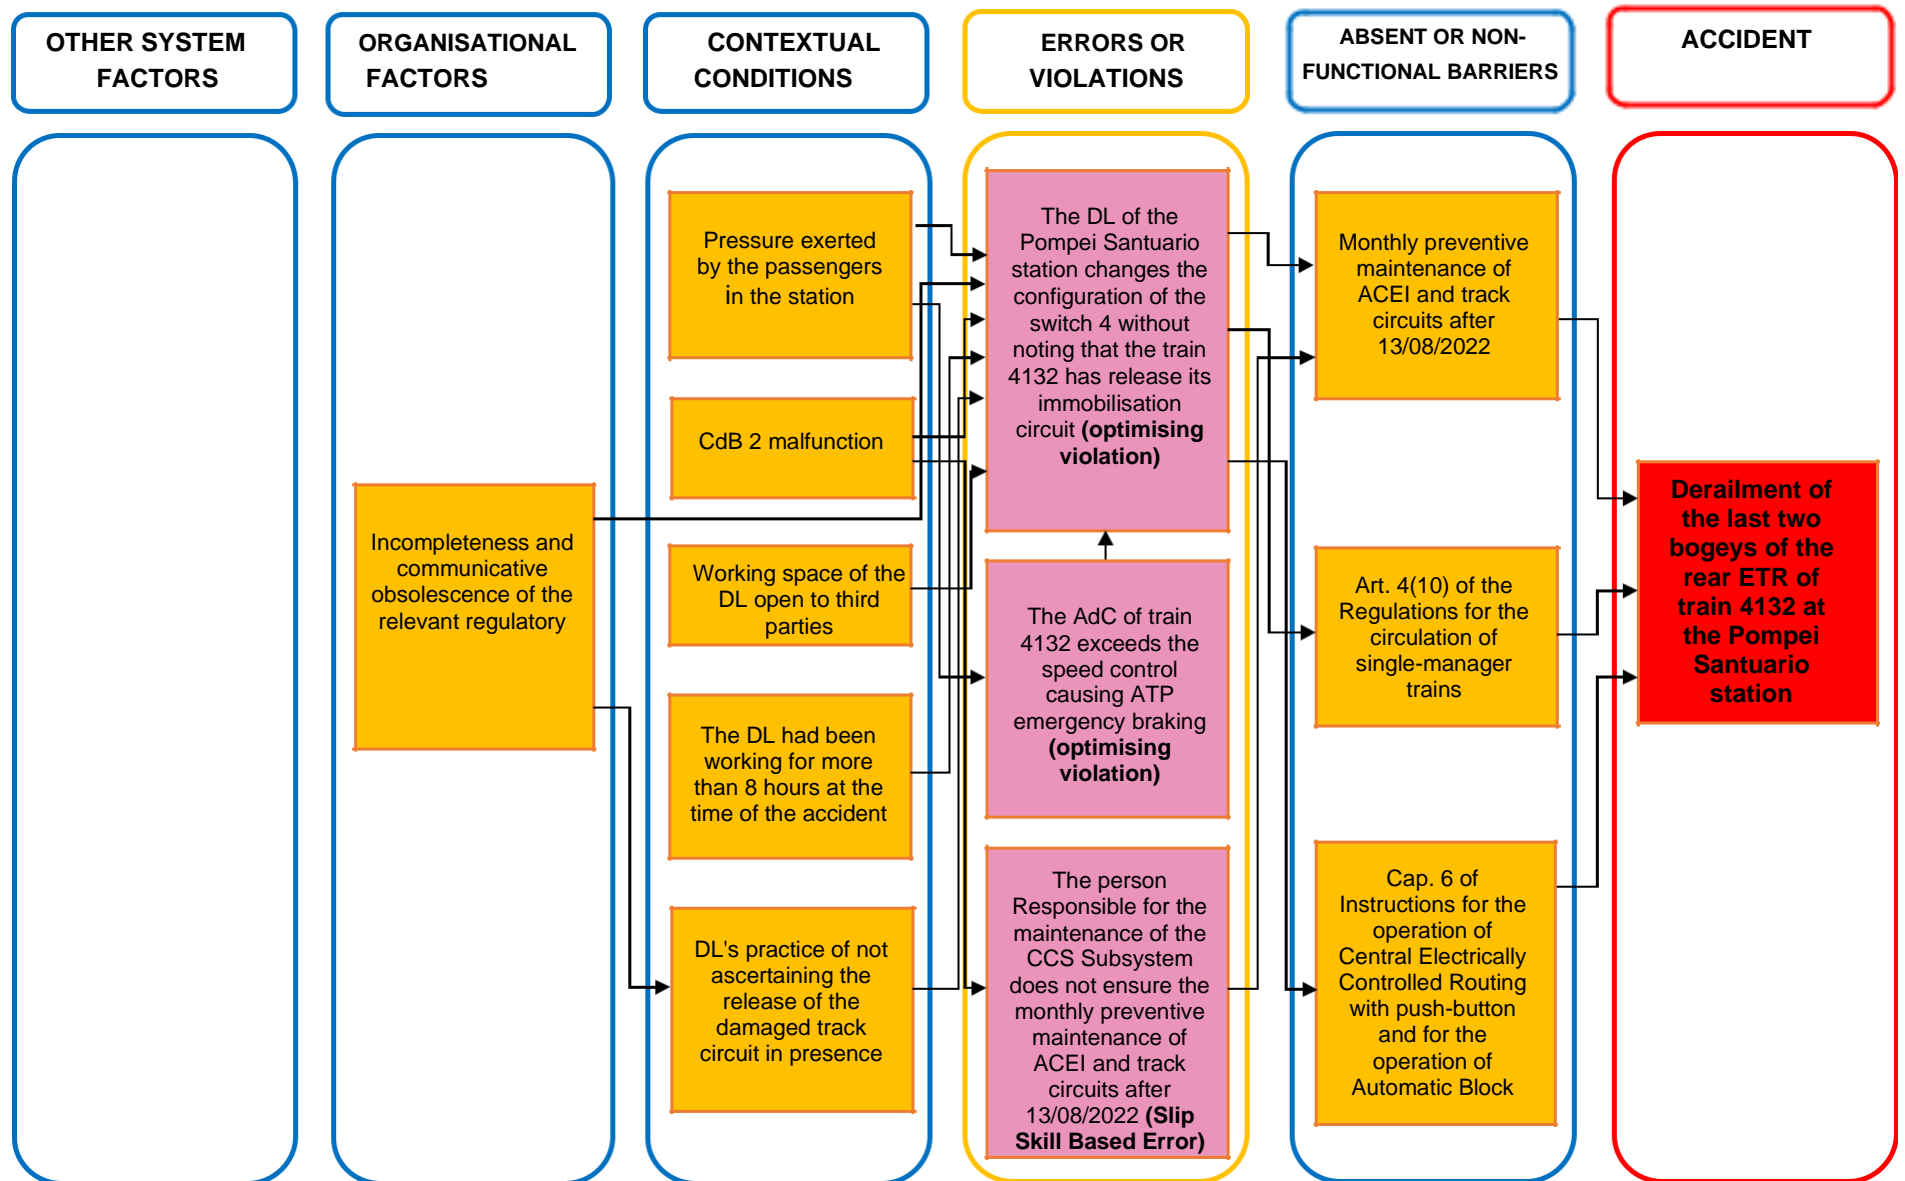
Figure 22-SOAM Diagram of the accident.

Finally, the indirect role played by the only organisational factor identified, represented by the incompleteness and communication obsolescence of the relevant regulatory provisions, all dating back more than a decade and requiring a thorough revision of language and content, should also be emphasised.
