Ministry of Sustainable Infrastructure and Mobility

DIRECTORATE GENERAL FOR RAIL AND MARITIME INVESTIGATIONS

INVESTIGATION REPORT

**DERAILMENT OF TRENITALIA PASSENGER
TRAIN 9595, HS/HC MILANO – BOLOGNA LINE,
AT PM LIVRAGA, ON 06/02/2020
(IDENTIFIER ERAIL: IT-6182)**

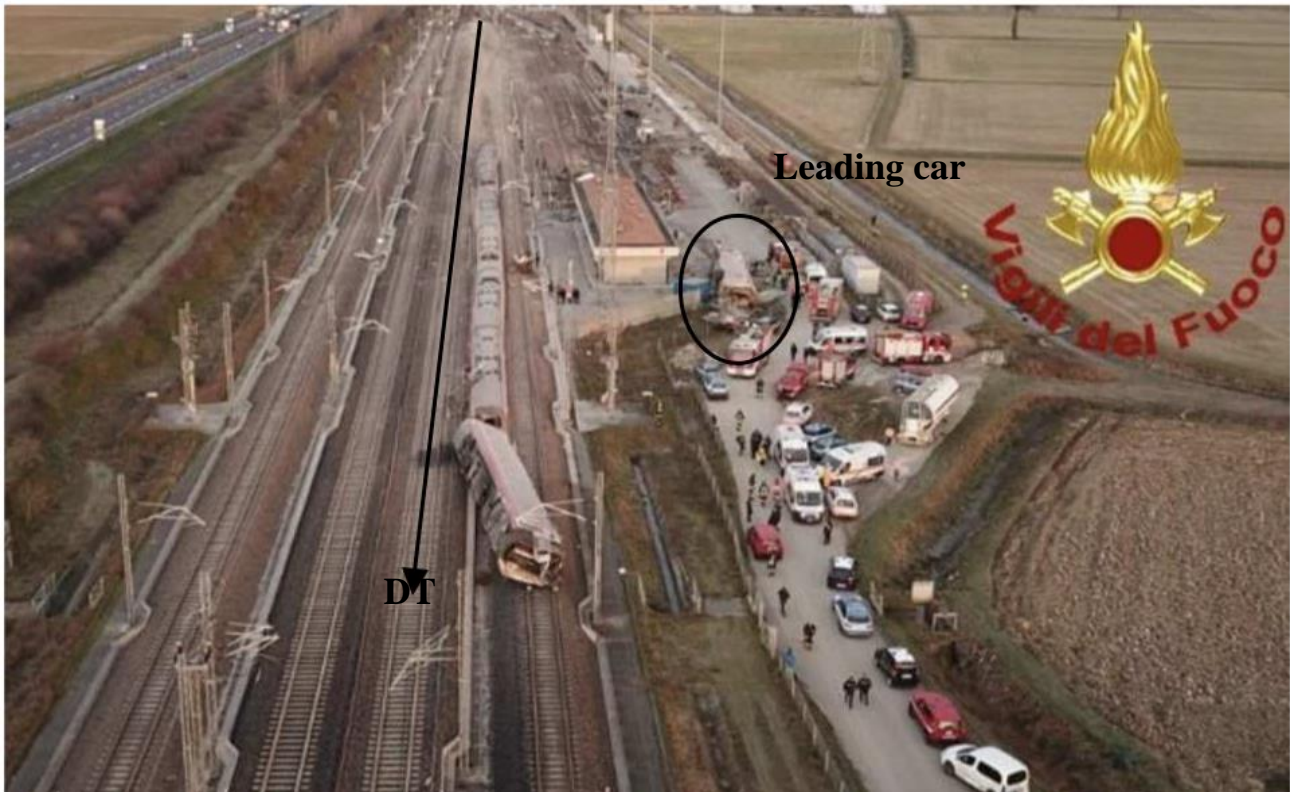
The entire train derailed but, while the leading car, detached from the others, broke through a fence and stopped its run on its side, close to the opposite side of the PM Livraga building, after colliding with some maintenance equipment stationed on a siding, to the left of the direction of the train (DT), the other seven cars continued their deceleration run off the rails and stopped in the inter-track between the odd-numbered track and the adjacent track, after travelling approximately 700 m from the initial point of the derailment, with the second DT car reversed on its side (*Figures 1, 2, 3 and 4*).

Figure 1 – Static position of the train following the accident (source: web)

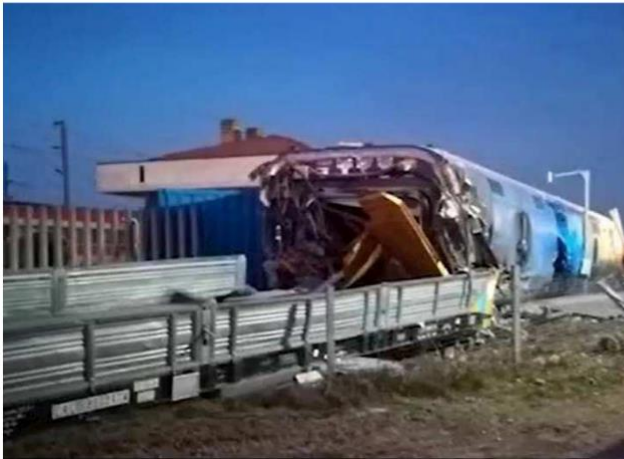
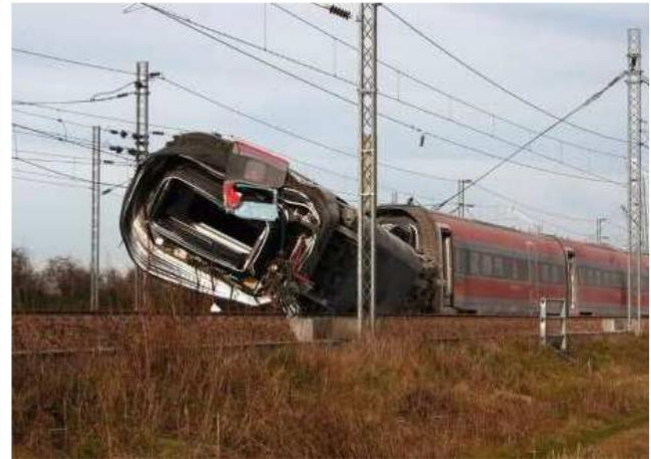
Figures 3 and 4 – Static position of the leading car, left, and cars no. 2 and following, right (source: web)

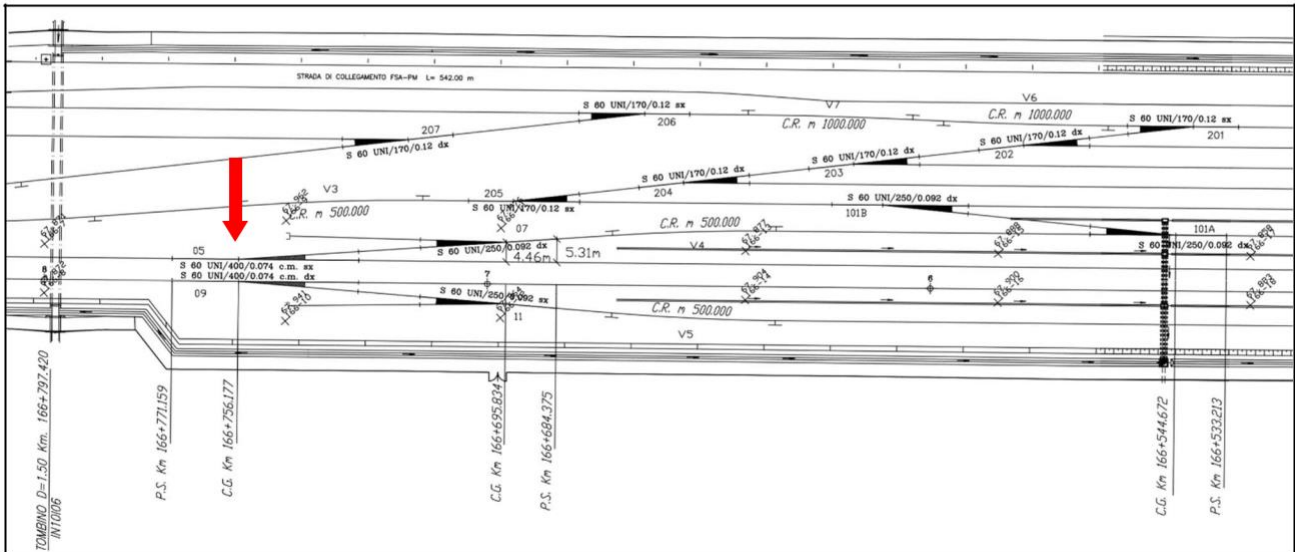
Figure 7 – Planimetry of the event route with evidence of the initial point of derailment: switch 05 at km 166+756 (source: RFI)

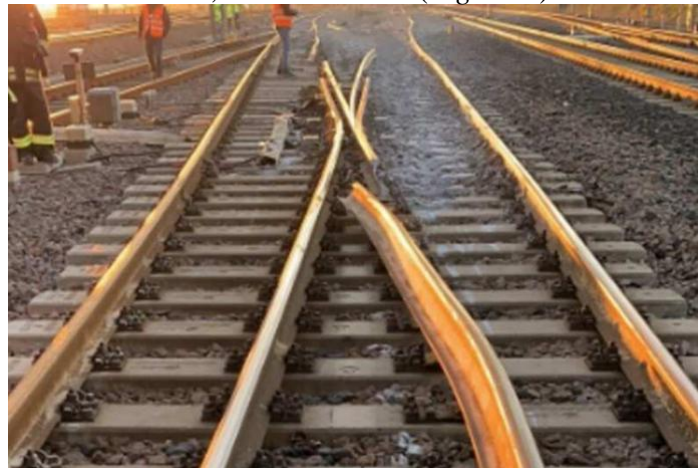
The initial point of the derailment on the track structure was located at switch 05, at km 166+756, where, due to the derailment, the rails broke (Figure 8).

Figure 8 – Initial point of derailment: switch 05 at km 166+756 (source: web)

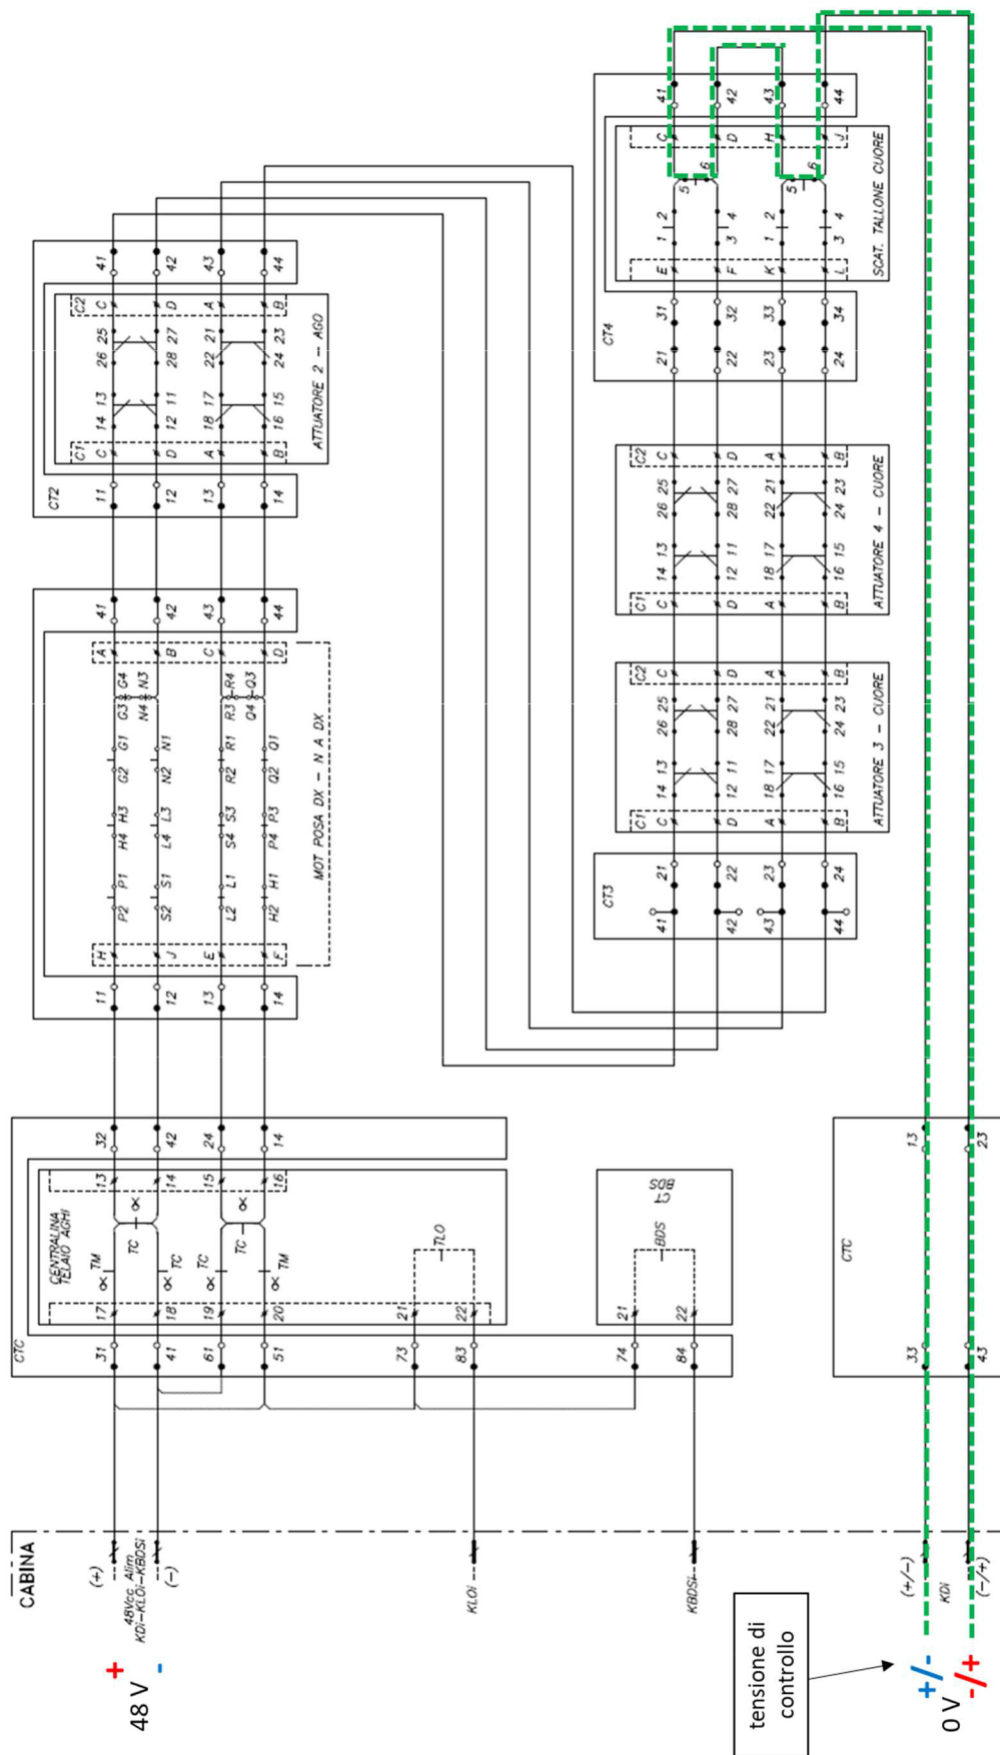
From a technical point of view, this solution allows a considerable simplification of the wiring of the control circuit, but it is not fail-safe in the event of wiring errors in the control circuit, as in fact occurred inside actuator no. 2 of switch 05 (serial no. 83).

Figure 39 - Switch control circuit: undefined position (elaboration: DiGiFeMa)

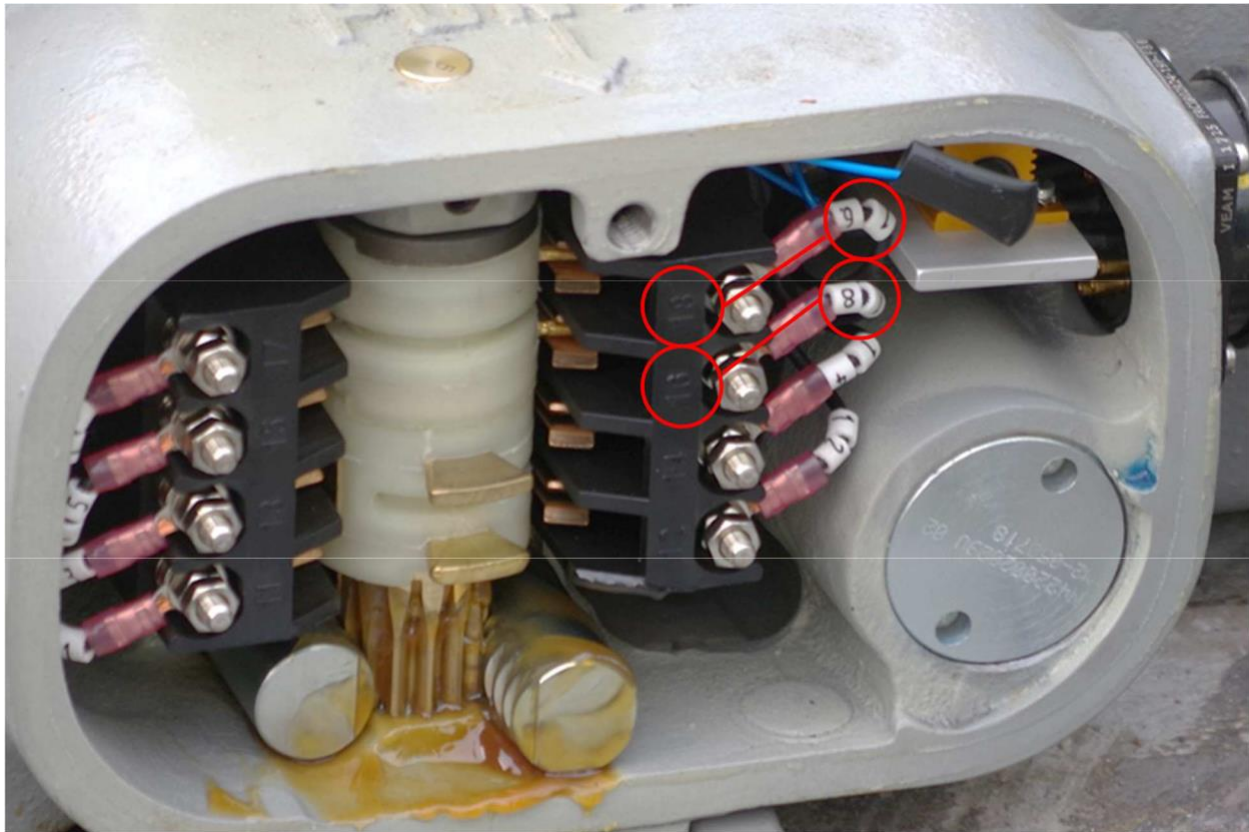
As also reported in paragraph 2.1.2 above, an examination of the electrical connections inside one of the actuator 2 boxes of switch 05, carried out immediately after the removal of the sealed cover, showed that:

- the contact shaft is in the configuration corresponding to the diverted position (closing contacts 17-18 and 15-16, opening contacts 13-14 and 11-12);
- the lugs marked with the numbers 16 and 18 are connected in an inverted manner to the corresponding contact shaft connection contacts (Figure 40).

Figure 40 - Actuator box no. 2 of switch 05 after the accident (source: DiGIFeMa)

It should be pointed out that this situation led to the abnormal operation of actuator no. 2 of switch 05 after it was replaced in the early hours of 06/02/2020. The wiring error within the actuator obviously changed the structure of the control circuit and, consequently, its operation. The following figures show the polarity assumed in this case by the position control relay from the yard (KDi) at the normal position (*Figure 41*) and diverted position (*Figure 42*) of the switch. Ultimately, the wiring error corresponding to the reversal of the connections in the actuator box causes the voltage applied to the position control relay to always have the same sign, corresponding to the normal position, regardless of the actual configuration of the switch.

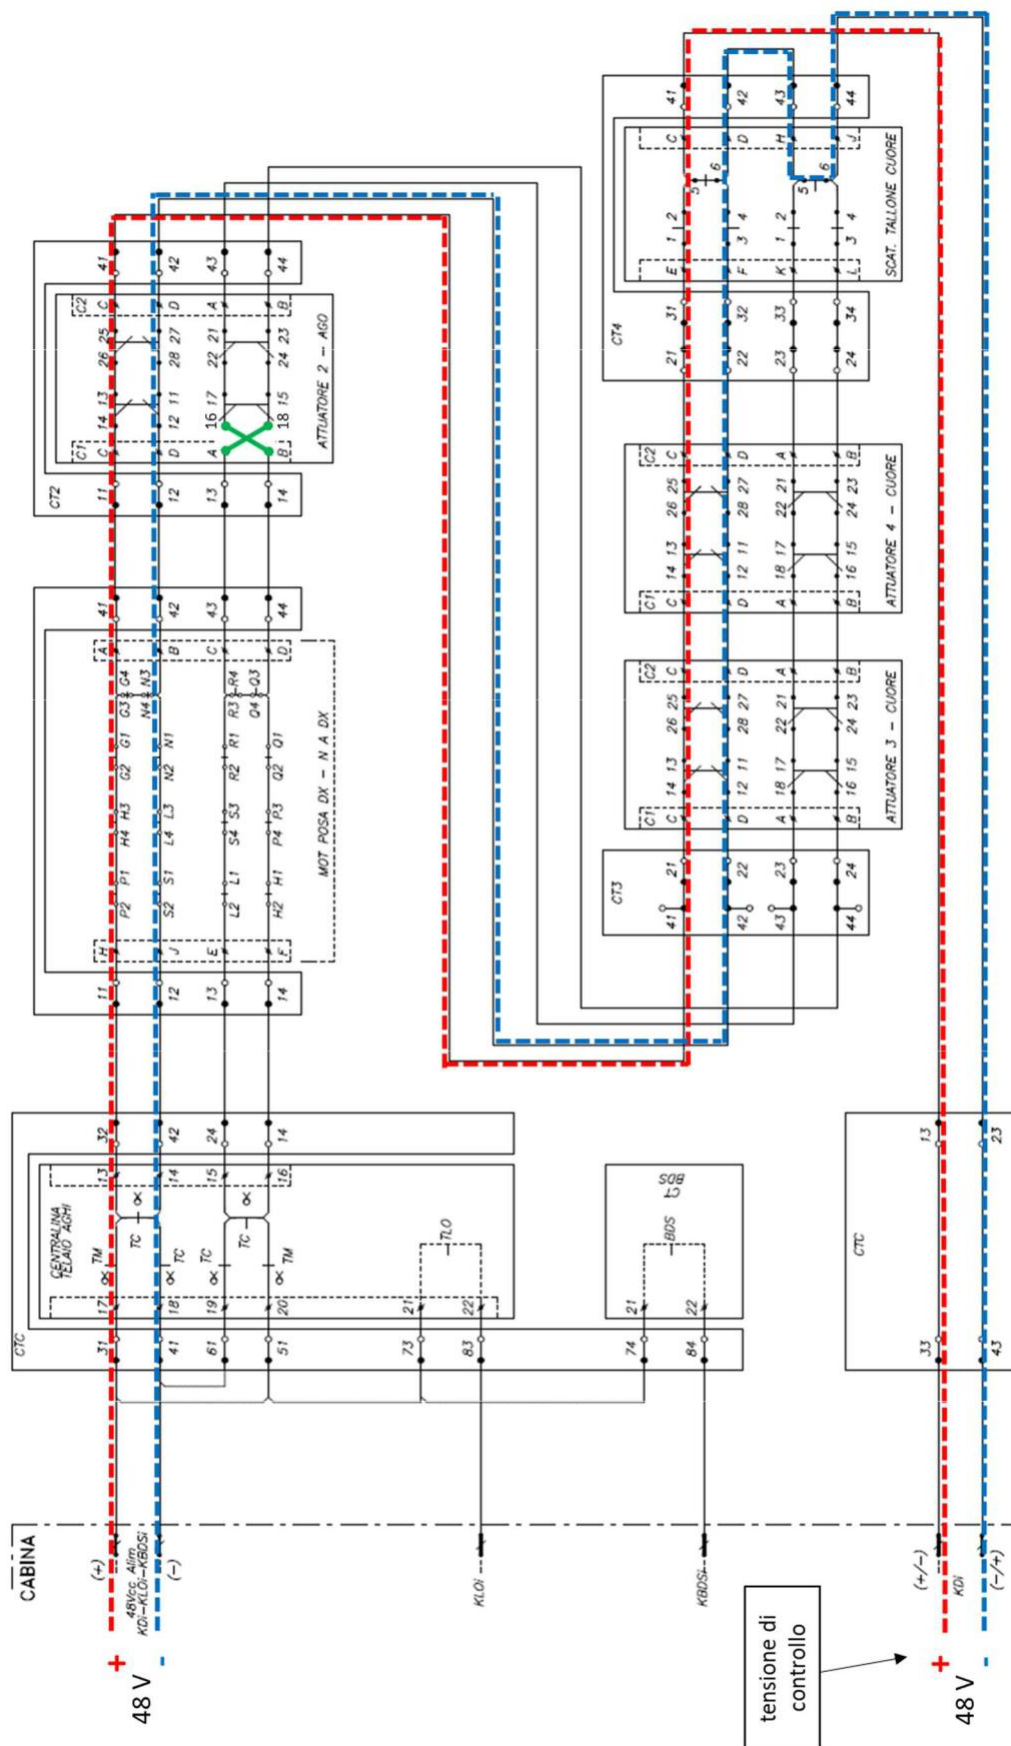
Figure 41 - Control circuit: normal switch position after actuator no. 2 replacement (elaboration: DiGIFeMa)

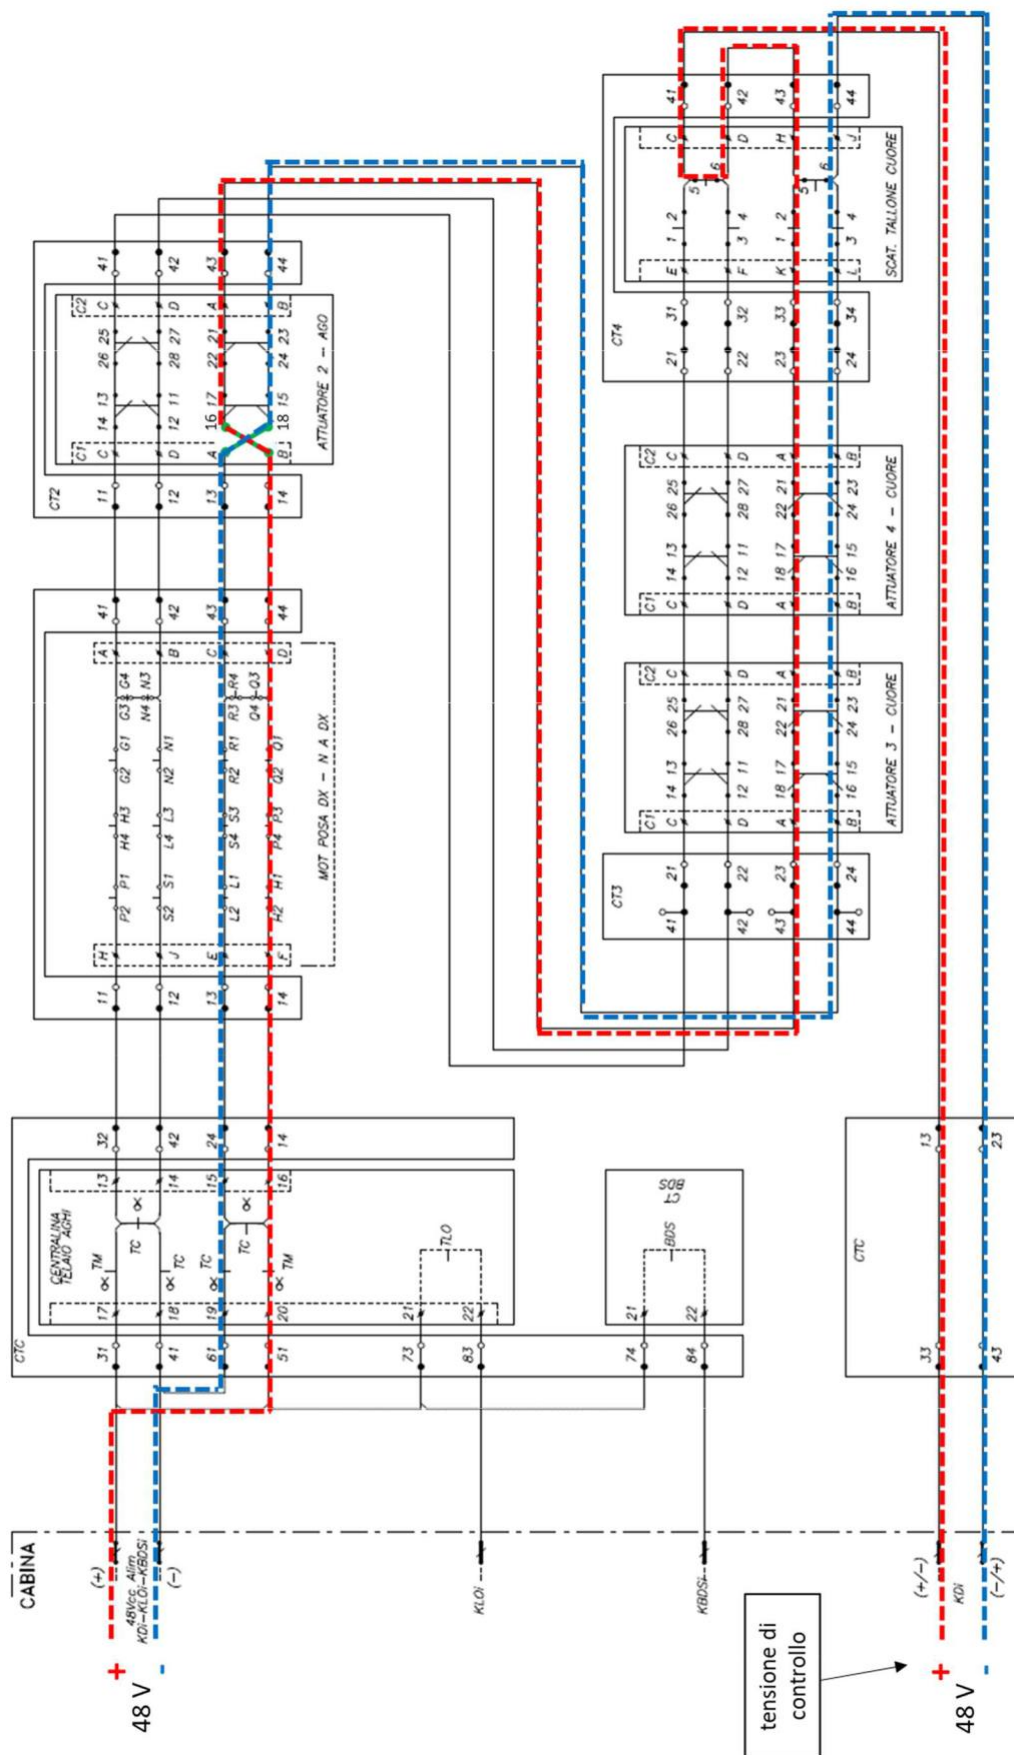
Figure 42 - Control circuit: diverted switch position after replacement of actuator 2 (elaboration: DiGiFeMa)
