General Directorate for Railway and Maritime Accident Investigation

***FINAL REPORT OF INVESTIGATION ON COLLISION BETWEEN M/N "MIKA" AND M/P
"LUGARAIN" RESULTING IN THE SINKING OF THE M/P "LUGARAIN" on 19 OCTOBER 2022
OFF THE COAST OF RAVENNA (EMCIP ref. 2022/018917)***

ROME, 27 November 2023

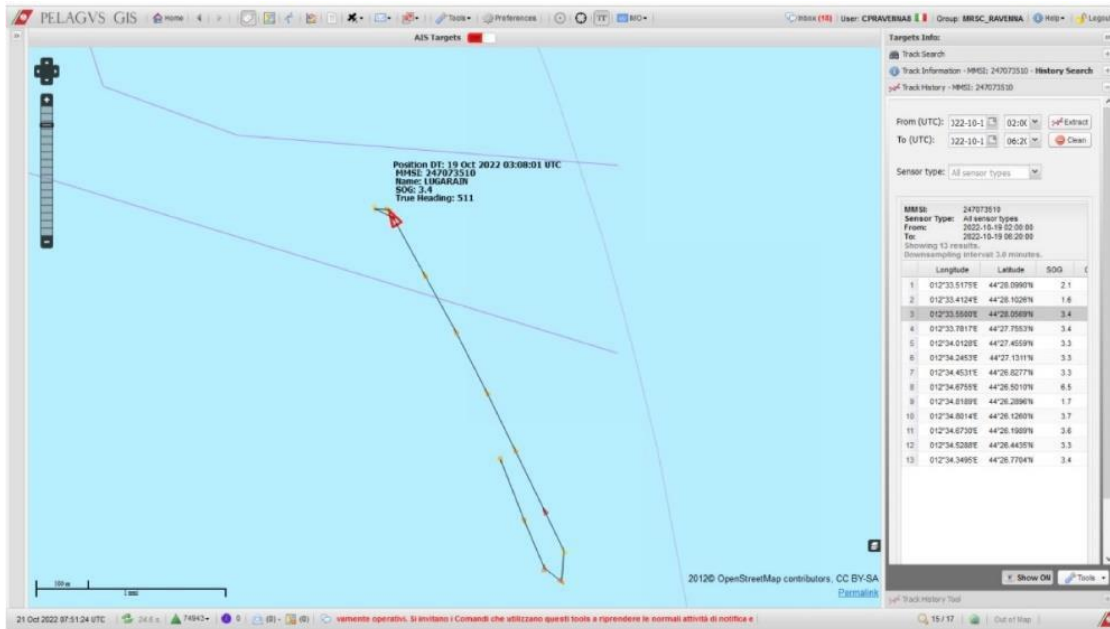
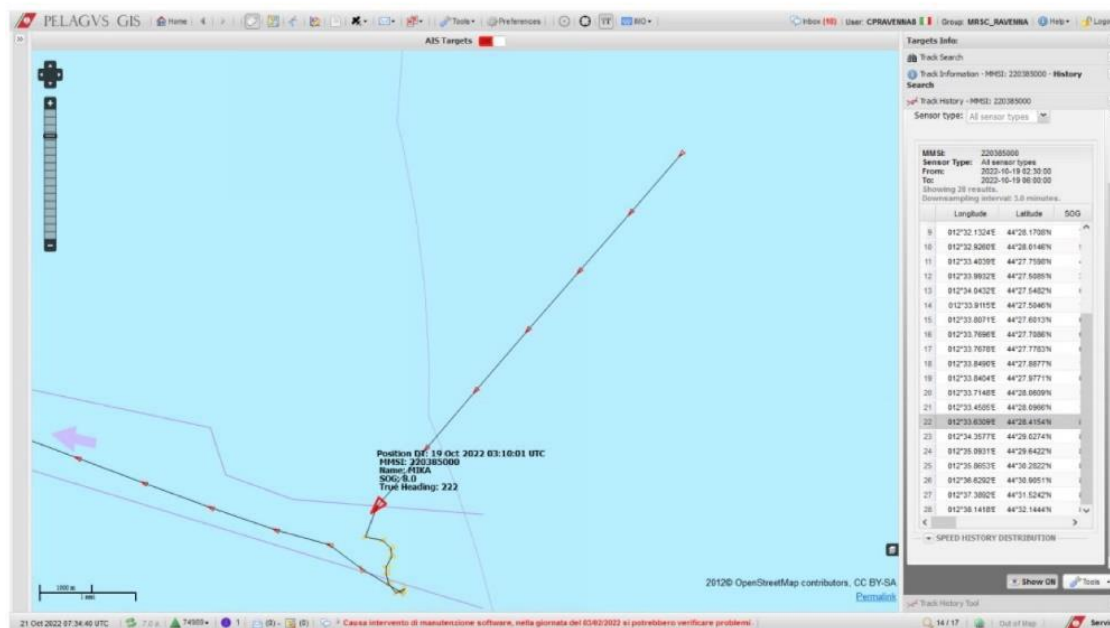
Figure no. 6 – PELAGUS Extract course of the vessels involved

- Violation 2 – The M/n “MIKA” enters the Traffic Separation Scheme in a way that does not comply with the navigation rules. As also highlighted in the report of the Ravenna Harbour Master's Office, the M/n “MIKA” “cuts” the entrance to the Traffic Separation Scheme (see Figure 6).

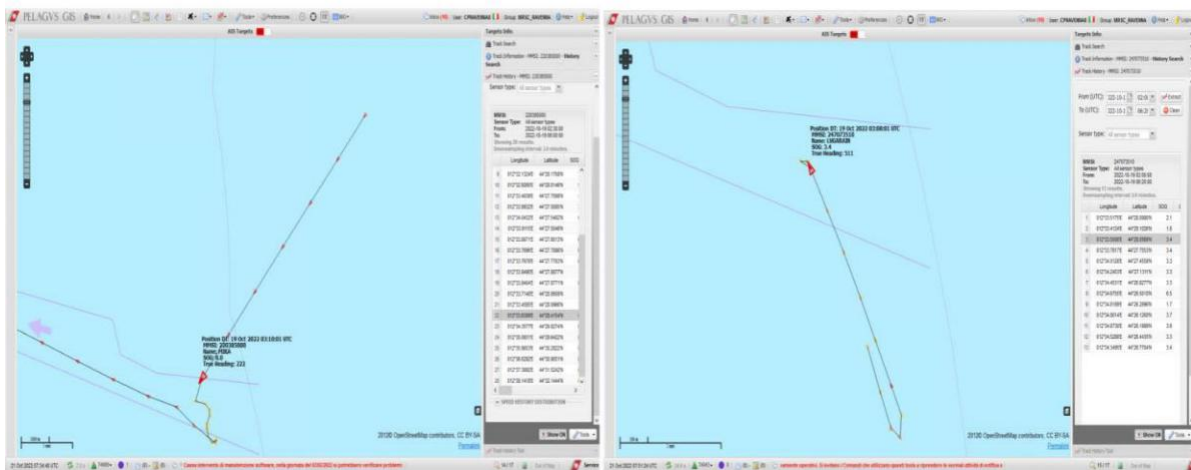
Figure 7 – Schematisation of the collision between the M/n “MIKA” and the M/p “LUGARAIN” (source: summary investigation report of the Ravenna Harbour Master's Office)

The M/n "MIKA" collided on the starboard side of the M/p "LUGARAIN" at 05:10 a.m./LT (03:10 a.m./UTC), in the position with coordinates latitude 44°28',46 N, longitude 012°33',09 E. An examination of the kinematic data collected, the statements made by the two captains and the damage suffered by both vehicles show that:

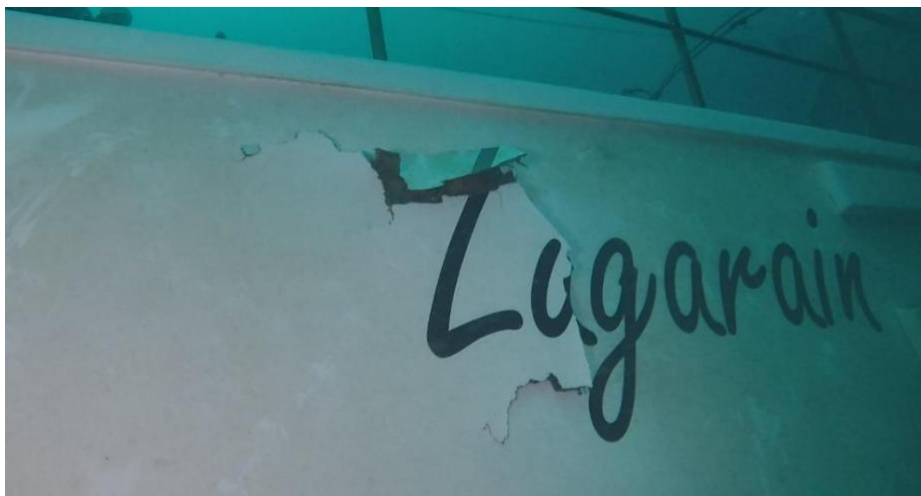
Figure 9 - Underwater shooting of the collision area of M/p "LUGARAIN"

An underwater inspection shows that the hull of the wreck suffers from a great deal of damage from the impact with the vessel, especially at the abaft of the starboard side, a leak that probably caused the shipwreck. Other damage to the hull is present on the left side but of little importance ⁽²⁾.

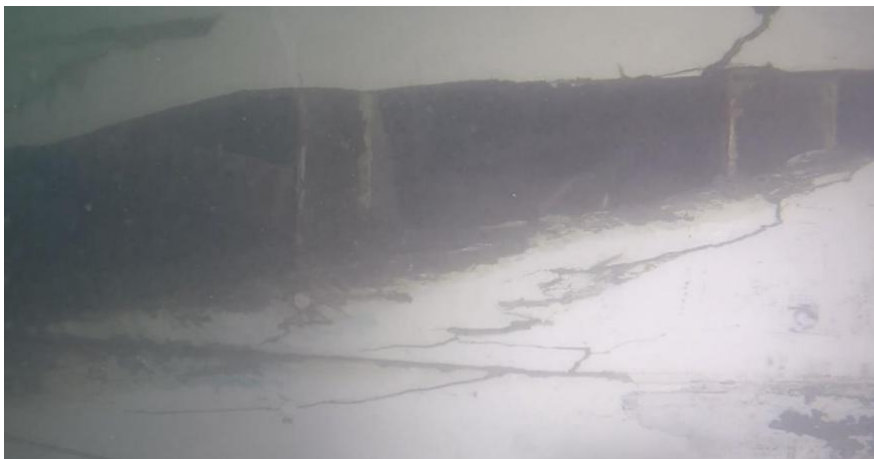
- the M/n "MIKA" did not suffer any significant damage to the forward submerged part of the vessel;
- the starboard side of the M/p "LUGARAIN" had a gash in the hull that generated a leak and caused it to sink.

Figure 10 - In the following image, a frame of the underwater shot is shown, from which the leak on the hull of the M/p "LUGARAIN" following the collision can be seen.

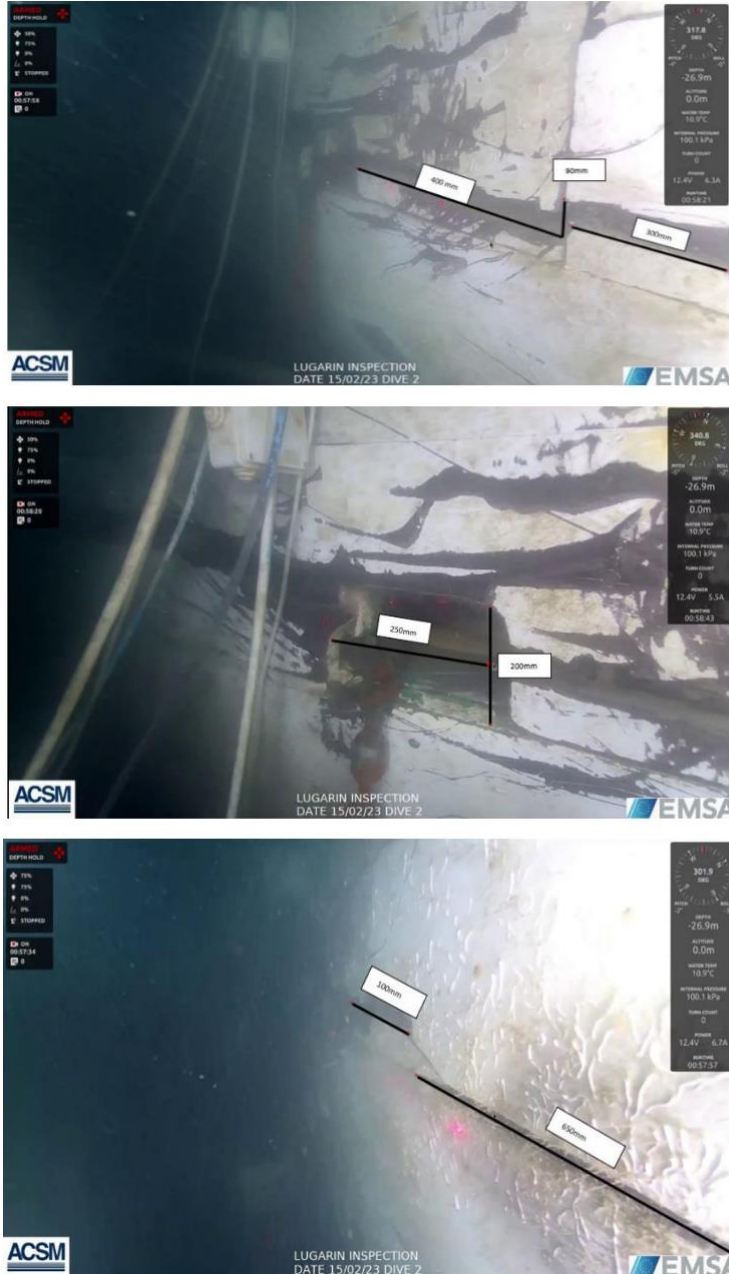
Figure 11 - Area of the M/p "LUGARAIN" affected by the collision
(source: photo report realised by ACSM)

- crack no. 1: 250 mm x 200 mm
- crack no. 2: 300 mm x 90 mm
- crack no. 3: 400 mm x 90 mm
- crack no. 4: 650 mm x 10 mm
- crack no. 5: 100 mm x 10 mm
