## FINAL MARINE SAFETY INVESTIGATION REPORT

**VESSEL NAME / IMO No** : SYN ZANIA / 9346938  
**FLAG** : Italy  
**LOCATION OF ACCIDENT** : PETKİM Petrochemical Plant / İzmir  
**DATE OF ACCIDENT** : 01.07.2019 / 23:15 LT  
**CASUALTIES** : 1/-  
**DAMAGE / POLLUTION** : Partial deformation and paint damage on the superstructure and accommodation / No pollution

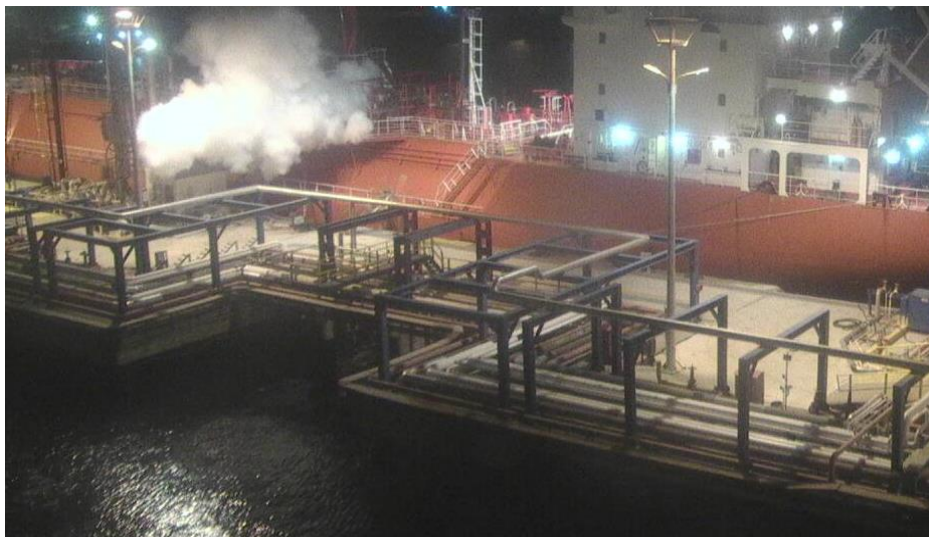
At 23:05, the pump is activated and it was proceeded to load the cargo in the liquid phase. In the meanwhile, the Loading Master was in his office at Berth 5 and the 1<sup>st</sup> Officer was in the Vessel Loading Control room. Approximately 6 minutes after the initiation of loading with the pump, around 23:11, a sudden gas leak occurred and about 10 seconds later, a massive explosion took place (*Figure 10 – 11 - 12*).

**Figure 10: The Moment of Leakage (23:11:35)**

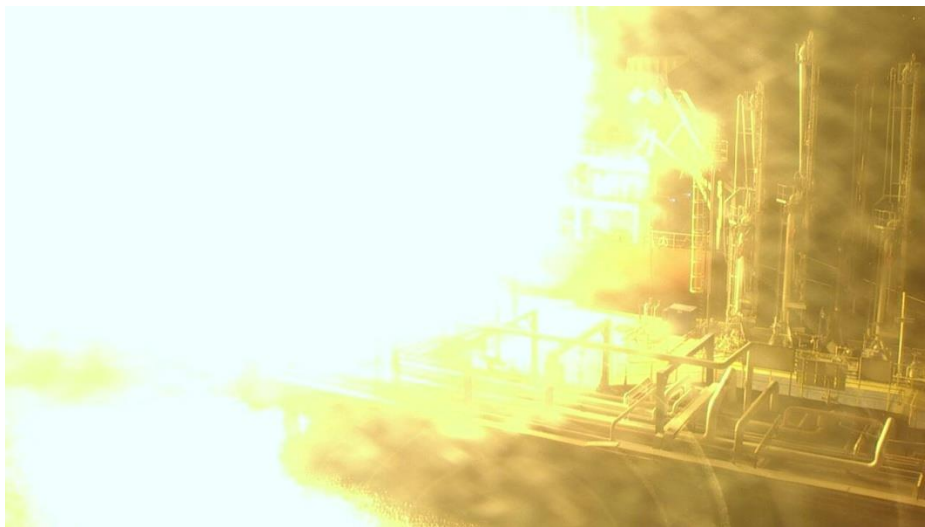
**Figure 12:** The Moment of Explosion (23:11:45)

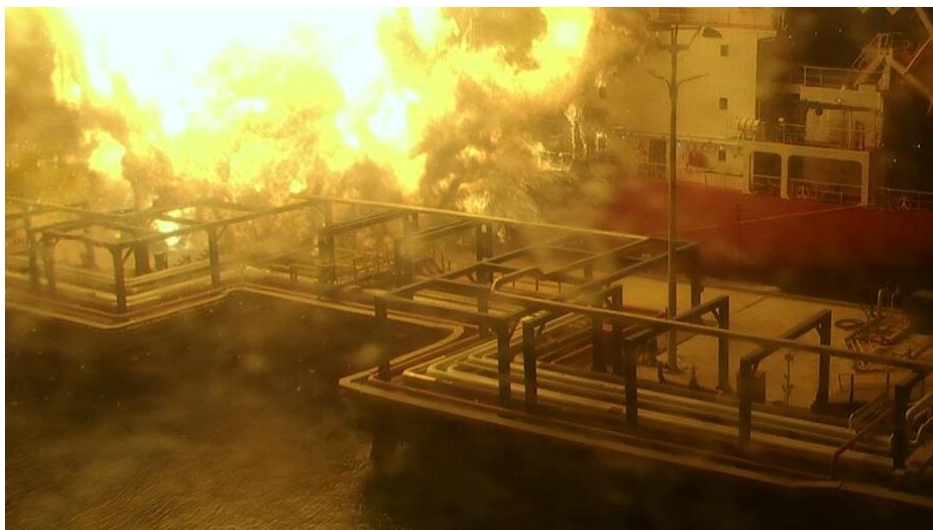
Following the explosion, the leaking gas started to burn (*Figure 13*). During the gas leakage, the seafarer who was on watch on the gangway at the port entry of the tanker rapidly moved towards the stern, where he considered to be a safe zone. In the meanwhile, there was no other crew either on the deck or on the berth. The Master was in his cabin, the 1<sup>st</sup> Officer and the Watchkeeper were in the Loading Control room, and the other crew were in various areas within the accommodation.

**Figure 13:** The Moment of Fire Outbreak (23:11:47)

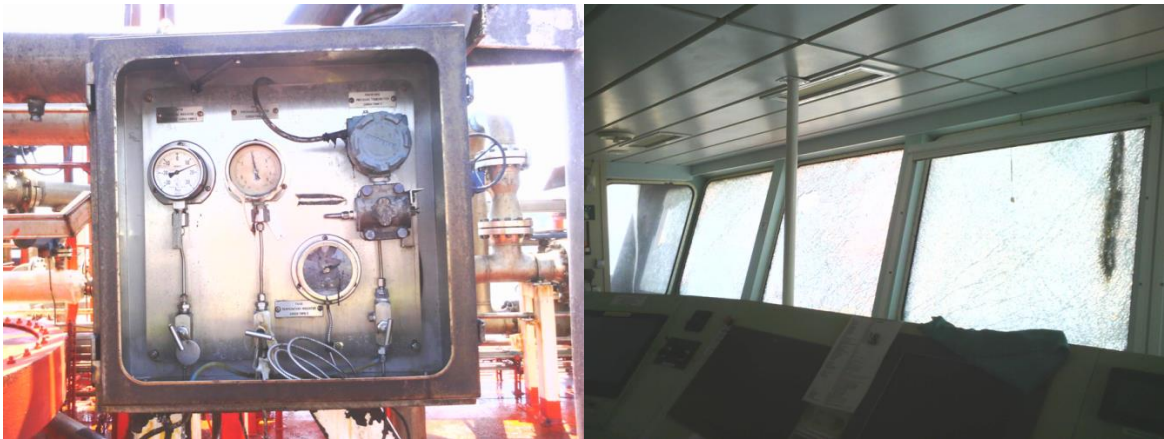
**Figure 20:** A Snapshot of Indicator Board and Bridge

In consequence of the investigations that were conducted after the accident, it was observed that various damages occurred on board and the coastal plant. Due to the massive explosion, windows on the wheelhouse and bridge wings and the glass of the pressure monitoring board on tank numbered two was broken. (*Figure 20*).

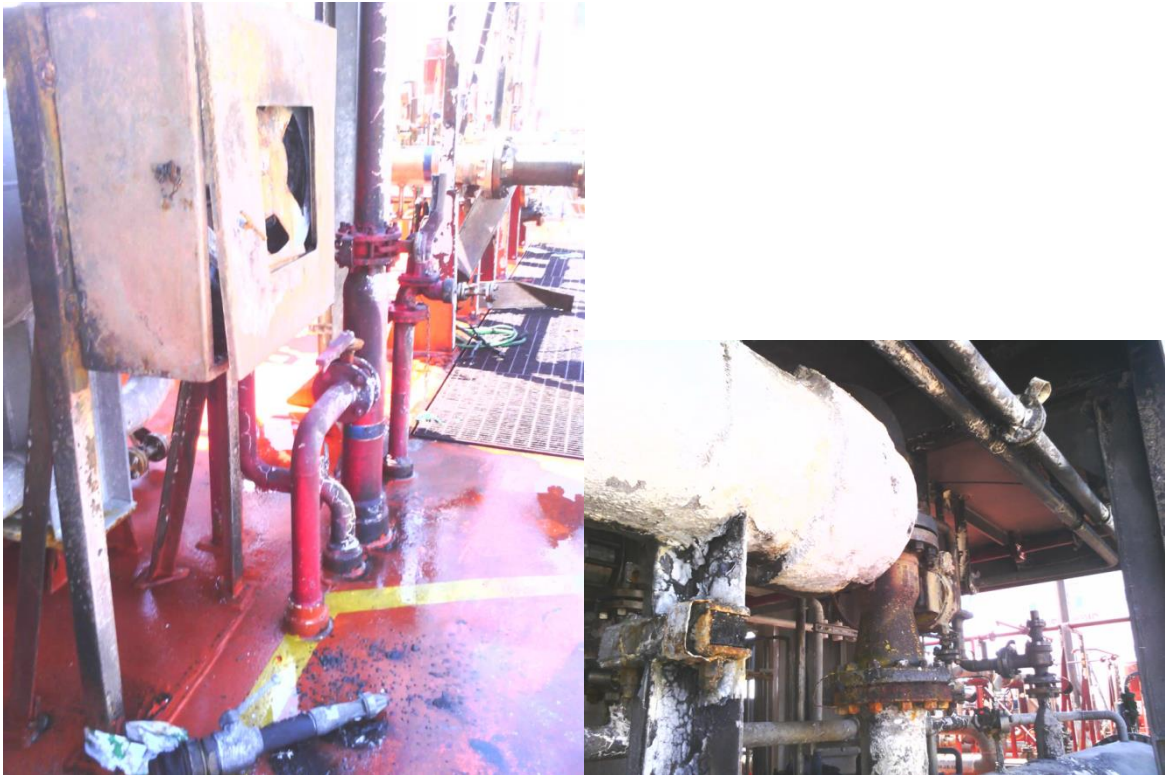
Figure 21: The Snapshots of Fire Hose Station and Insulation Materials

As a result of the fire broke out after the explosion, the plastic and insulation materials on deck and fire-fighting hoses burned. Further, the deformations and coating burnt on the steel parts of the vessel due to the ongoing fire draw attention (*Figure 21*).

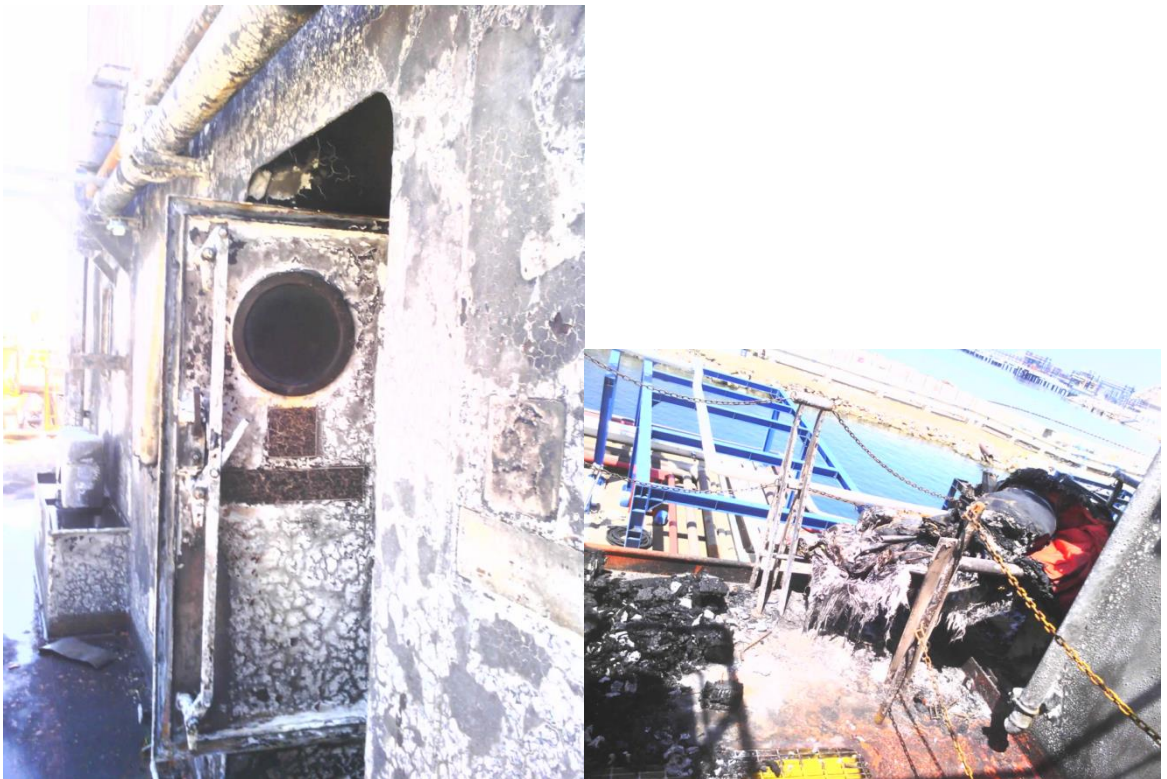
Figure 22: The Snapshots of Accommodation Structure and Life Raft

Several coating burnt and material burnt are noticed in the accommodation on the port side of the deck. One of these is the life raft on the lifeboat deck (*Figure 22*).

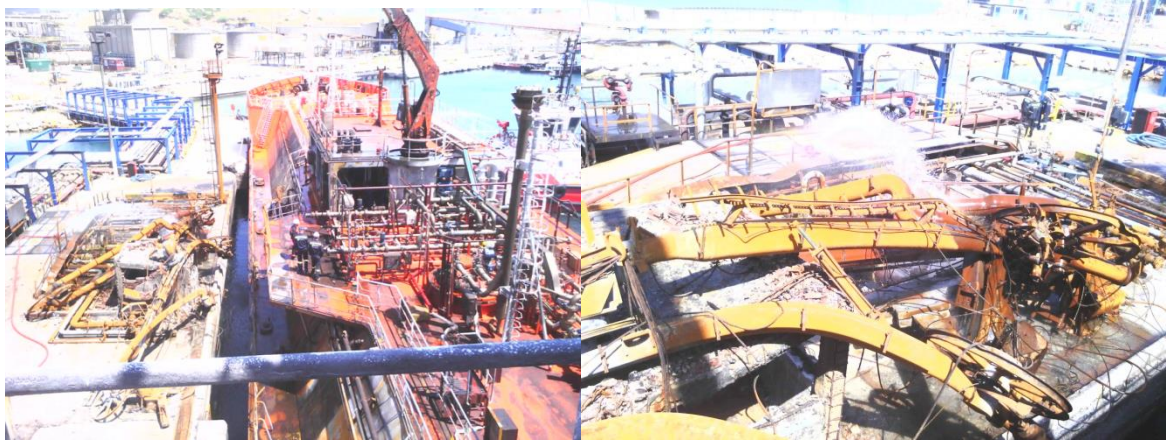
Figure 23: The Snapshots of Berth Damage

Furthermore, serious damage on the berth was observed. Loading-unloading units on the berth, which was the most affected area by the fire, collapsed together with the concrete structure due to the heat. Additionally, local deformations and coating burnt on the piping system that was located on the berth also draws attention (*Figure 23*).

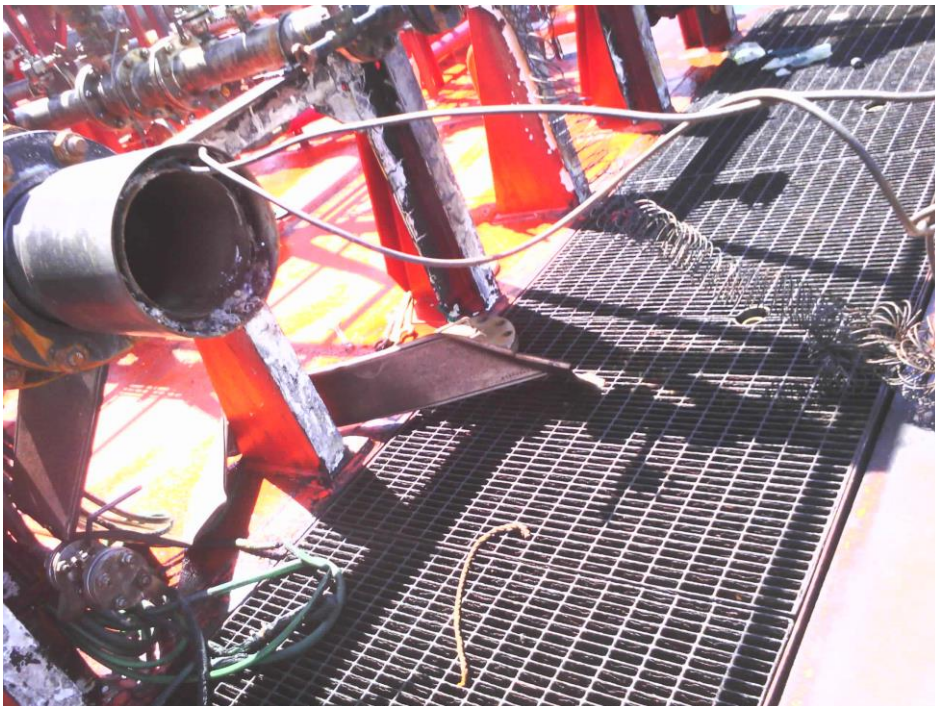
- The Loading-Unloading hose that was used for the connection between the tanker and the shore was ruptured 5-6 minutes after proceeding to the liquid phase of the loading operation and after 10-15 seconds, the leaking gas was first exploded by reaching its flashing point likely because of static electricity and thereafter begun to burn.

- The Loading-Unloading hose that was used in loading operations was complying the standards, however, due to the fact that the pressure in loading lines was ranged at 35 bars and above for 5 minutes, the pressure quantity that the Loading-Unloading hose could resist per unit tested was exceeded and thereby the hose was ruptured.

- A sparkle that developed due to the friction caused by the spiral wires that were exposed by the rupture of the Loading-Unloading hose being rubbed against each other or the vessel (*Figure 24*),
- Heat dissipation of any heat-protected lightings located onboard and on the port plant in a way to cause ignition.

Figure 24: A Snapshot of the Loading-Unloading Hose after Fire Fighting

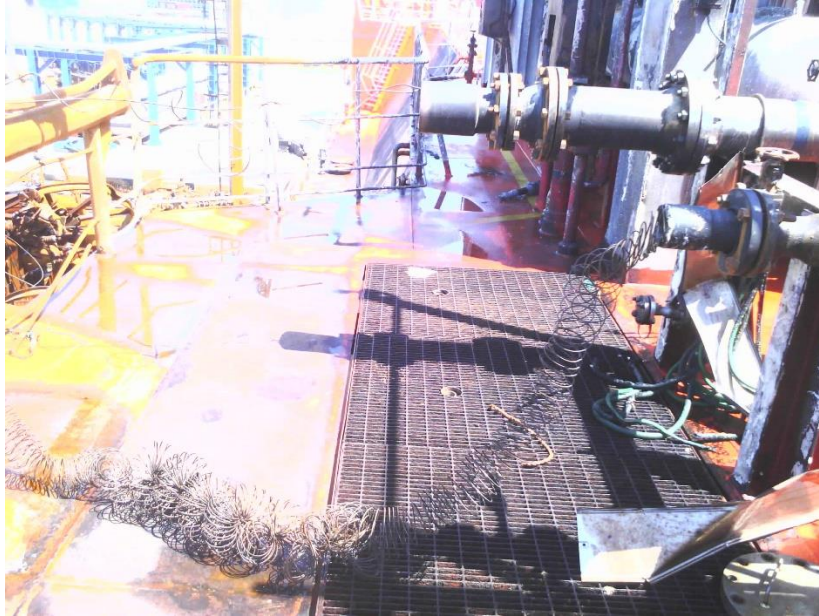
Additionally, another hose of 3 inches in diameter and 4 meters in length was used to allow a gas return. The reduction was used to enable the hose flanges to correspond with the vessel manifolds (*Figure 26*)

**Figure 26:** Appearance of the Hoses after Fire Fighting

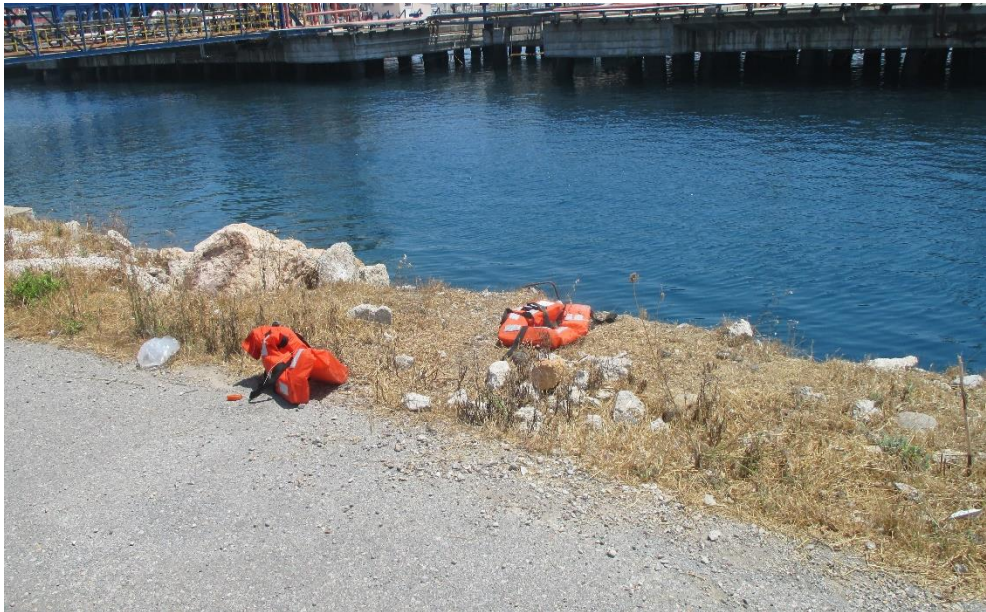
As can be understood from the autopsy report of the 2<sup>nd</sup> engineer who lost his life, the fact that the cause of death is drowning has once again indicated the importance of the use of equipment to survive in the sea.

**Figure 27:** Life Jackets Found at the Shore
