# **Italian Ministry of Infrastructure and Transport**

## **INVESTIGATION REPORT**

## BREAK-UP RAIL GOODS TRAIN NO. 58006, NEAR BARLETTA, ON THE TRANI – BARLETTA ROUTE, ON 04/01/2022 (ERAIL IDENTIFIER: IT-10253)

27/11/2023

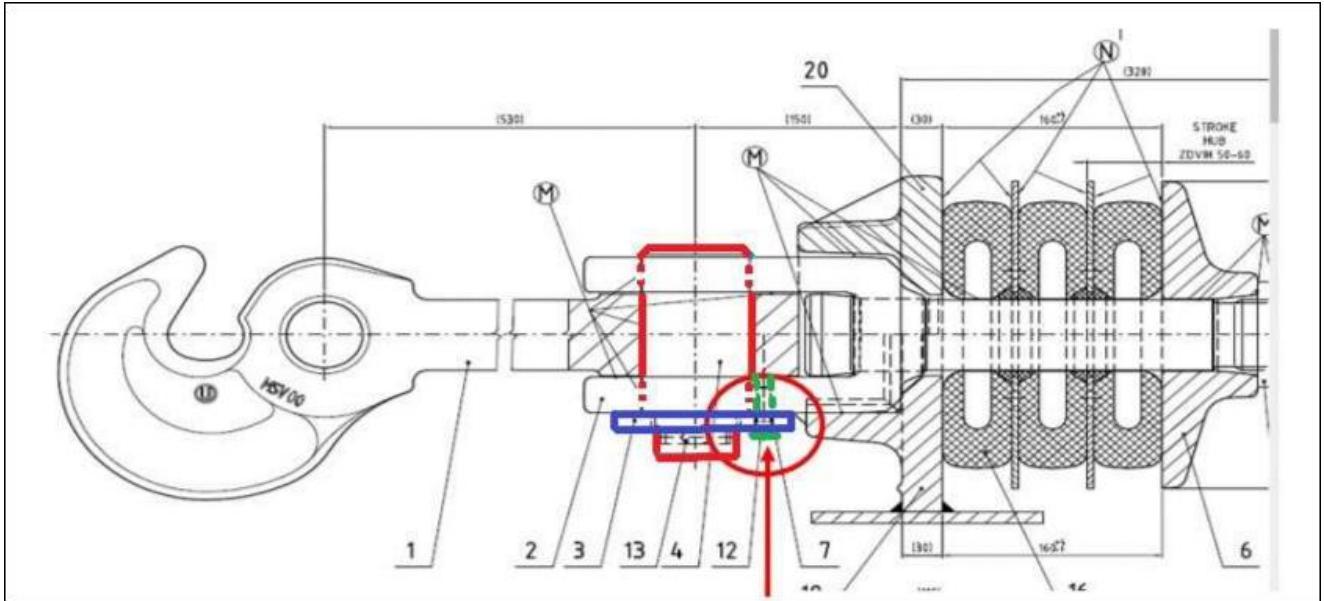
Figure 2 – Pulling rod (GTS source)

In this type of wagon, the pulling hook is attached to the pulling rod (figure 2) with a pin that is inserted from below for structural reasons; therefore, it must be held in the position required by means of retaining.

The pin itself consists of two parts: a shaped steel cylinder, highlighted in red in Figure 2, with one extremity having a smaller diameter, and a plate attached to the pin by a linchpin, in blue in Figure 2.

The pin is held in the working position by the plate attached to it, which is bolted to the pulling rod by two bolts, also screwed from below, highlighted in green in Figure 2. In turn, the bolts are held in place by bending over the bolt heads of the flaps of a plate held in place by themselves (Figure 3).

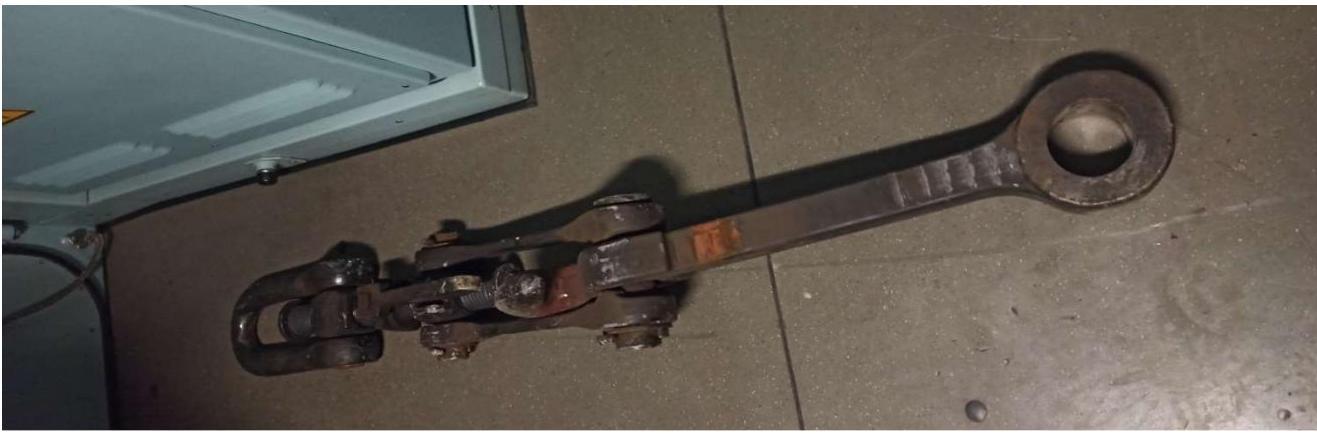
Figure 4 – Wagon pulling hook 33 54 4962 476-6 (GTS source)

From the inspection carried out on the site, the pulling hook was found immediately after the event (Figure 4) and the king-pin (Figure 6) between the hook and the pulling rod during a subsequent inspection carried out on 14/01/2022.

Neither the pin fastening bolts nor the respective locking plate where found.

Both the pulling hook and the pin show no signs of damage.

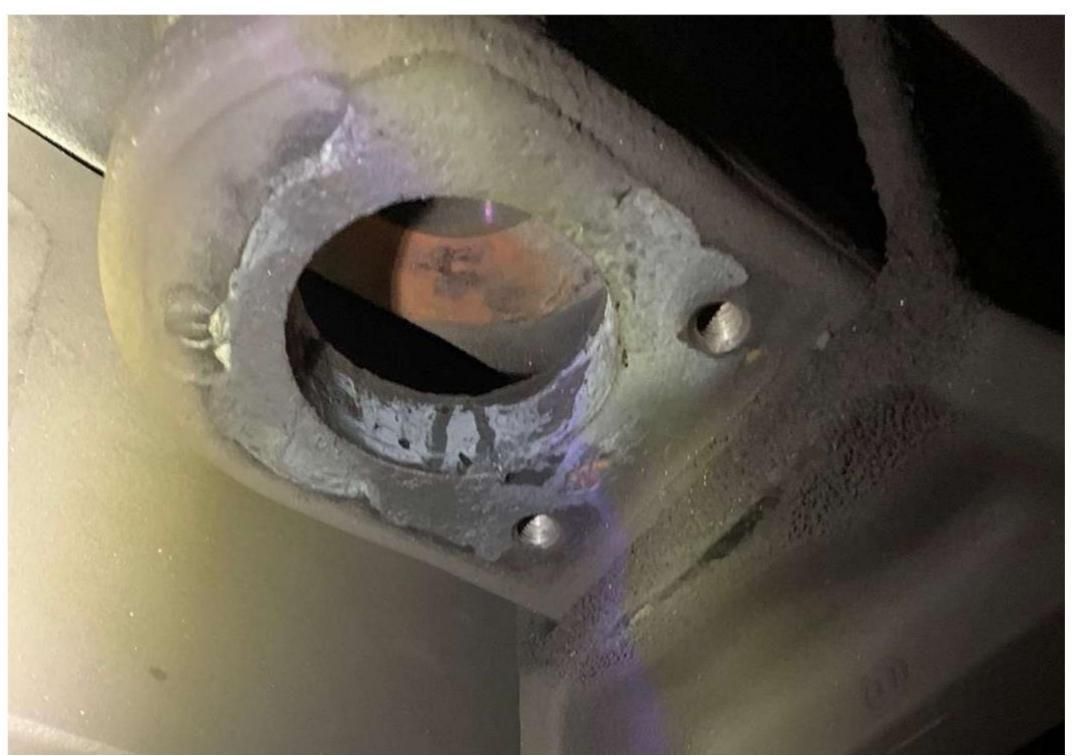
Figure 5 - Wagon Pulling rod 33 54 4962 476-6 (GTS source)

Figure 5 shows the pulling rod of the wagon from which the pulling hook slipped out, which also shows no defects and is undamaged.

Since the pulling hook and its pin, as well as the eyelet of the pulling rod of wagon 33 54 4962 476-6 are intact, it can be assumed that the loss of the pin occurred due to the unscrewing of the fasting bolts, despite the presence of the locking plate.

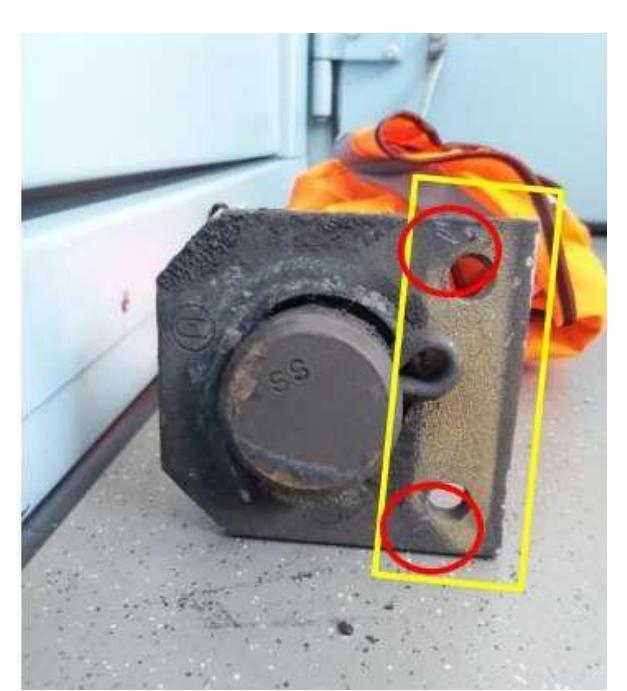
Figure 6 – Wagon hook fastening pin 33 54 4962 476-6 (GTS source)

In fact, the fastening pin has the print that shows the presence of the plate (Figure

furthermore, the shape of the print shows that it was bent, so it is likely that it was bent incorrectly, allowing the bolts and the plate to be unscrewed and subsequently lost.

The pin retaining bolts have probably been unscrewed due to incorrect bending of the locking plate of the pin retaining bolts (3rd secondary cause)

It is recommended that the Agency for Railway, Road Infrastructure and Motorway Safety ensure that GTS Rail and other railway undertakings, when purchasing new wagons, verify, or have verified by ECM, the presence and correct installation of the hook-fastening attachments to the pulling rod, including their restraint systems (bolts and plate) and keep documentary evidence of this.

It is recommended that the Agency for Railway, Road Infrastructure and Motorway Safety ensure that manufacturers in charge of the manufacture and construction of vehicles, when assembling the traction vehicles, ensure that the hook attachments are correctly installed to the pulling rod, included the restraint systems (bolts and plate).
