## **INVESTIGATION REPORT**

**DERAILMENT OF TRAIN 4132 OF THE EAV RAILWAY  
UNDERTAKING ON THE LINE NAPLES – TORRE ANNUNZIATA  
POGGIOMARINO, AT THE POMPEI SANTUARIO STATION, ON  
07/11/2022**

(ERAIL IDENTIFIER: IT-10335)

10 November 2023

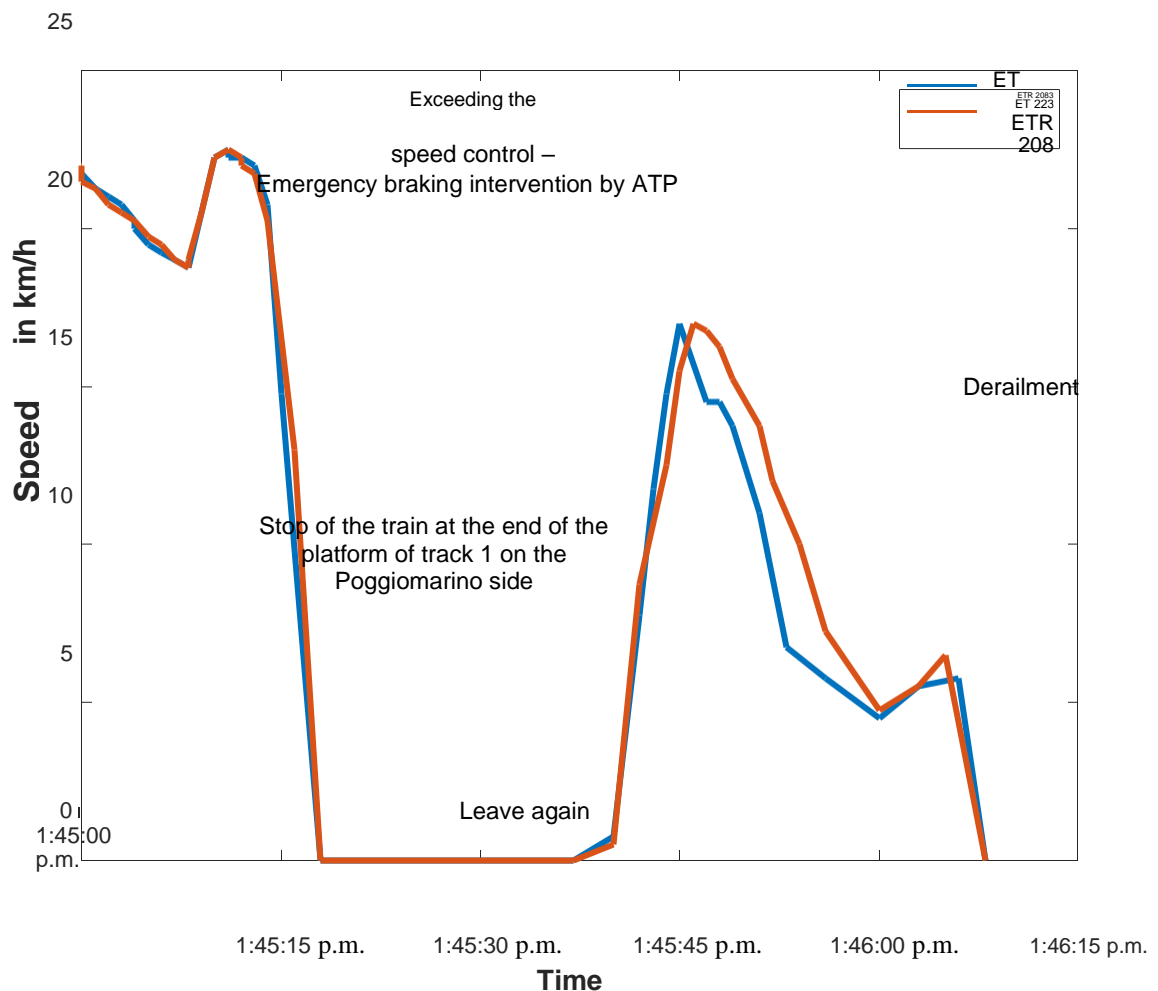
However, the analysis of the data provided by the tachograph zones of the two electric trains ETR 223 and ETR 208, which formed train 4132, provides a different reconstruction of the evolution of the facts. As evidence of this, see Figure 14, which shows the speed trend of the two electric trains at the entrance to the Pompei Santuario station, which is obtained from the processing of data provided by the tachograph zones.

From the analysis of that figure, it is immediately noted that train 4132:
