Ministry of Sustainable Infrastructure and Mobility

DIRECTORATE GENERAL FOR RAIL AND MARITIME INVESTIGATIONS

INVESTIGATION REPORT

**DERAILMENT OF TRENITALIA PASSENGER
TRAIN 9595, HS/HC MILANO – BOLOGNA LINE,
AT PM LIVRAGA, ON 06/02/2020
(IDENTIFIER ERAIL: IT-6182)**

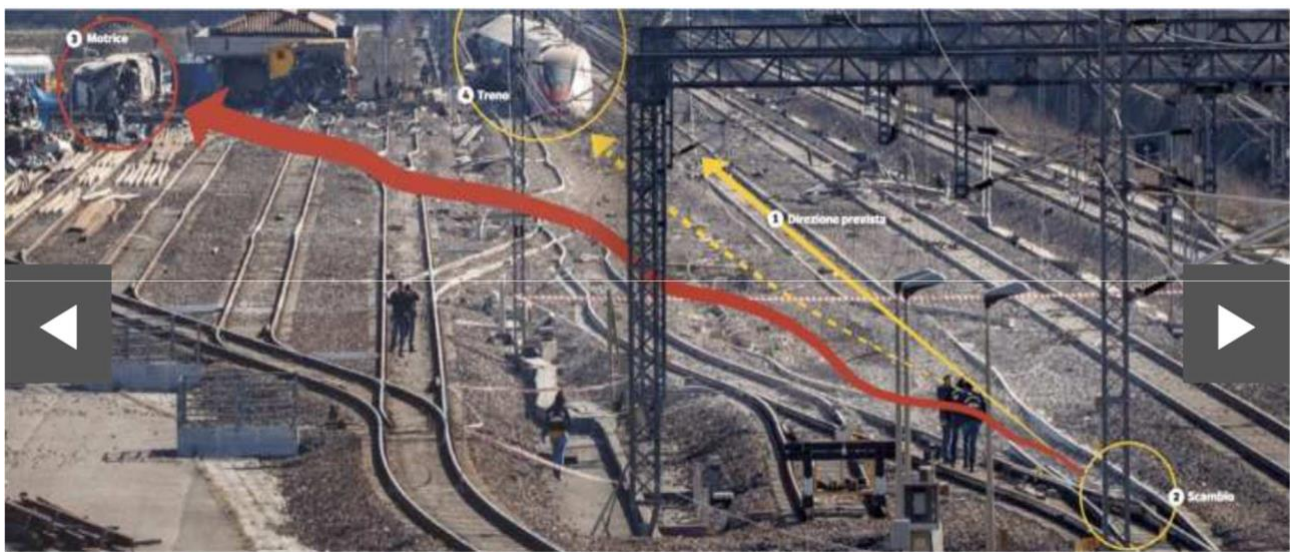
Figure 2 – Schematic reconstruction of the dynamics of the accident (source: web)

The entire train derailed but, while the leading car, detached from the others, broke through a fence and stopped its run on its side, close to the opposite side of the PM Livraga building, after colliding with some maintenance equipment stationed on a siding, to the left of the direction of the train (DT), the other seven cars continued their deceleration run off the rails and stopped in the inter-track between the odd-numbered track and the adjacent track, after travelling approximately 700 m from the initial point of the derailment, with the second DT car reversed on its side (*Figures 1, 2, 3 and 4*).

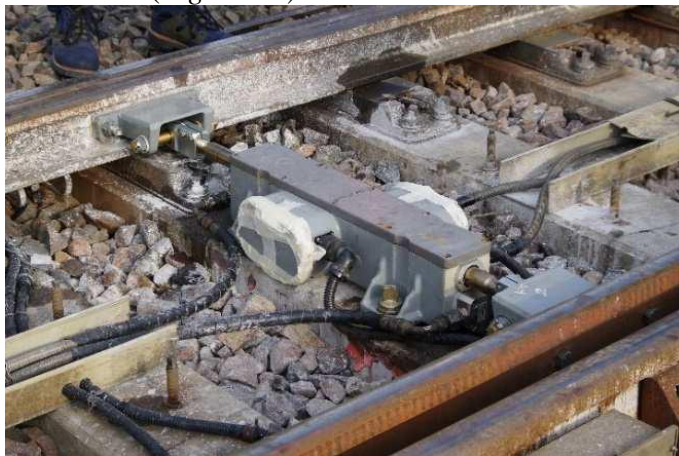
Figure 12 - Infrastructure equipment near the point of derailment (Source: DiGIFeMa)

At km 166+756, where switch 05 is located, the initial point of the train's derailment, the track is straight and slightly uphill. Switch 05 is of type SO 8 with tg 0.074 with a movable point core, year of installation and activation 2008 (*Figure 12*).

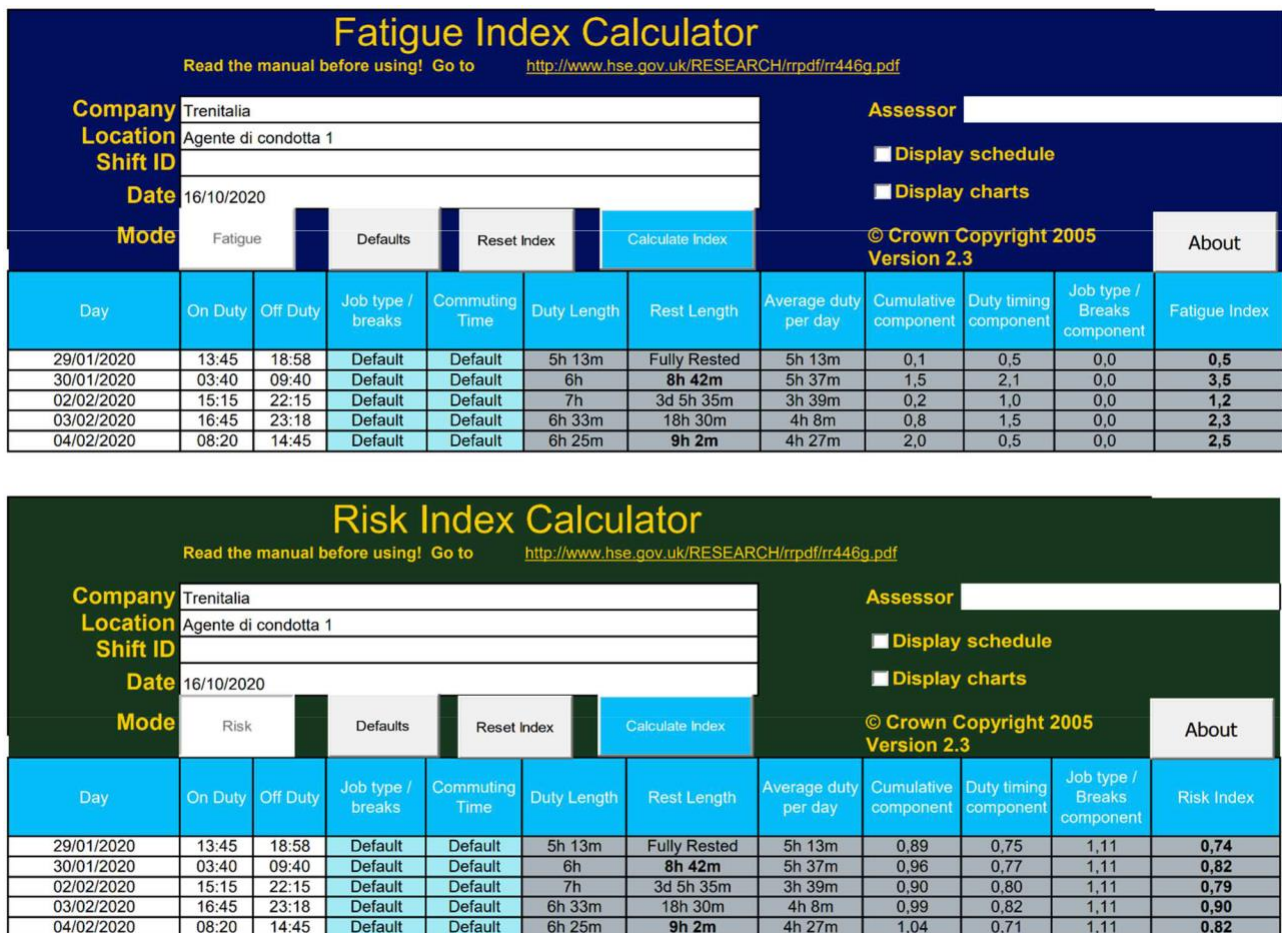
Figure 26 - Fatigue Index and Risk Index for Driver 1 (data: Trenitalia - elaboration: DiGIFeMa)

In particular, the shifts worked by Driver 1 produced a maximum Fatigue Index value of 3.5% and a maximum Risk Index value of 0.90 (Figure 26).

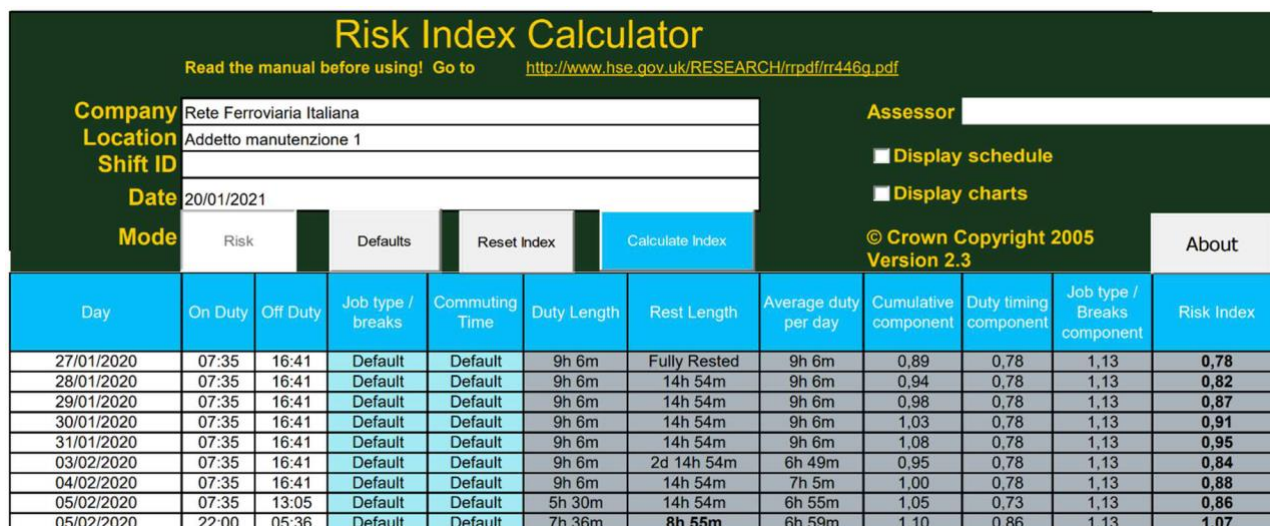
Figure 28 - Fatigue Index and Risk Index for Maintenance Agent 1 (data: RFI - elaboration: DiGIFeMa)

The shifts worked by Maintenance Agent 1 produced a maximum Fatigue Index value of 19.1% and a maximum Risk Index value of 1.07 (Figure 28).

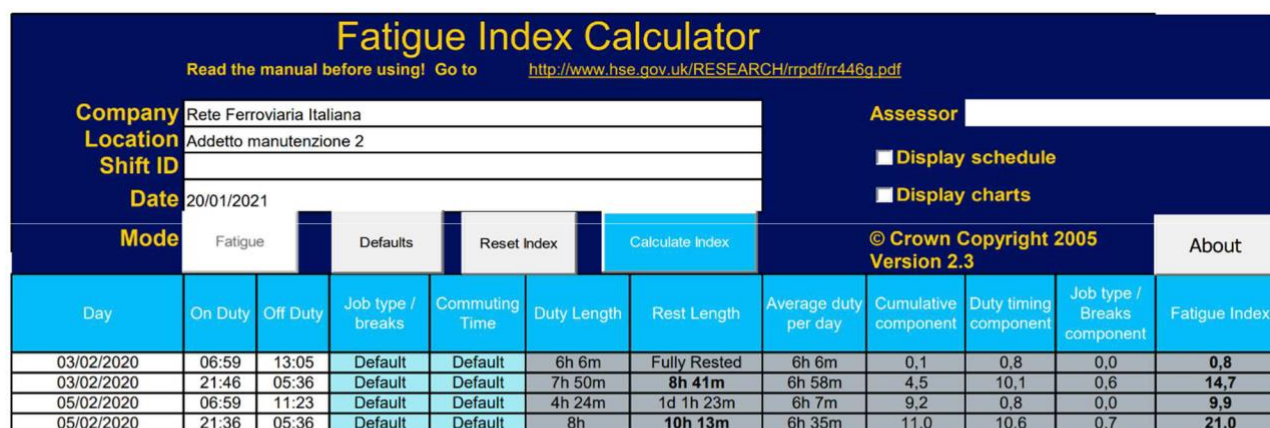
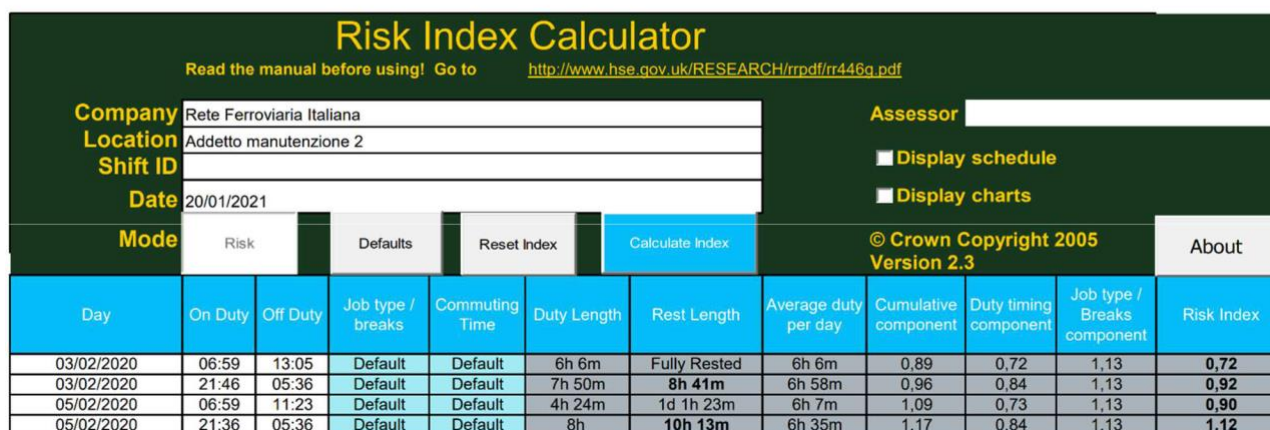
Figure 29 - Fatigue Index and Risk Index for Maintenance Agent 2 (data: RFI - elaboration: DiGIFeMa)

The shifts worked by Maintenance Agent 2 produced a maximum Fatigue Index value of 21% and a maximum Risk Index value of 1.12 (Figure 29).

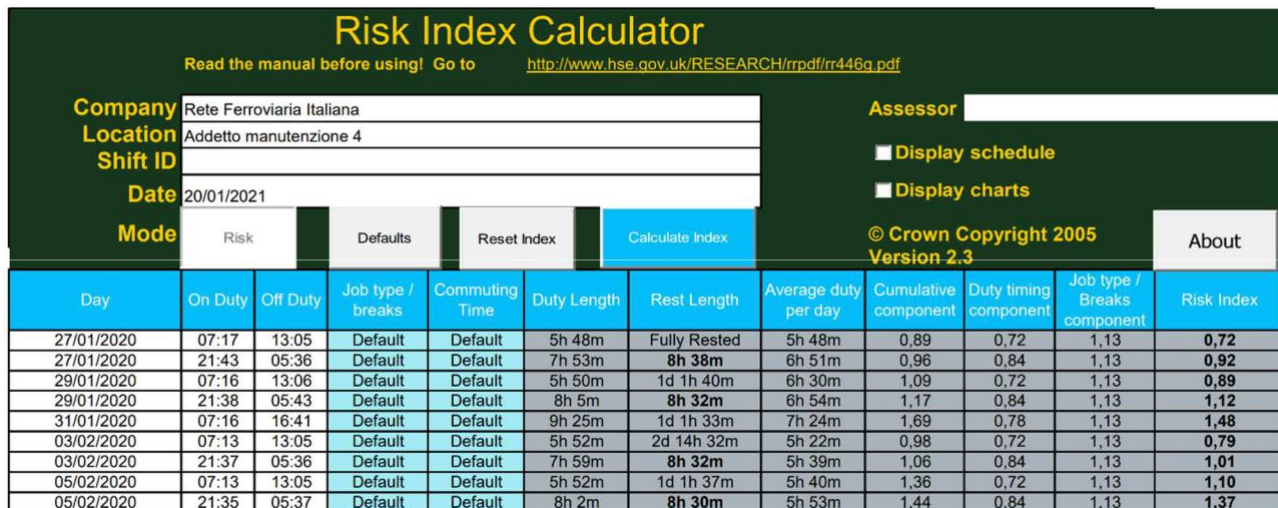
Figure 31 - Fatigue Index and Risk Index for Maintenance Agent 4 (data: RFI - elaboration: DiGIFeMa)

The shifts worked by Maintenance Agent 4 produced a maximum Fatigue Index value of 26.3% and a maximum Risk Index value of 1.48 (Figure 31).

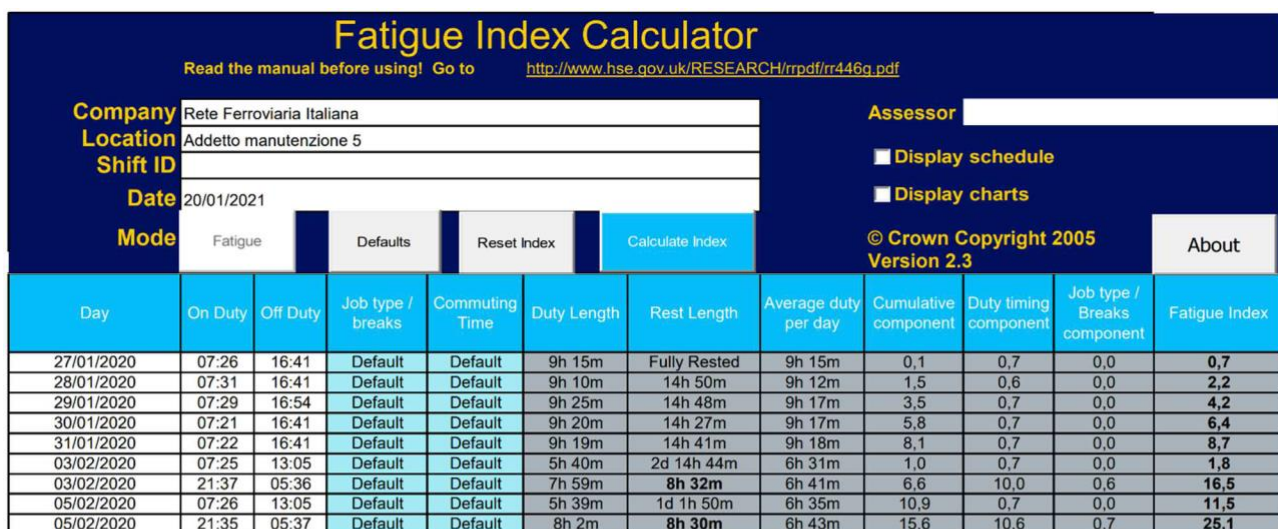
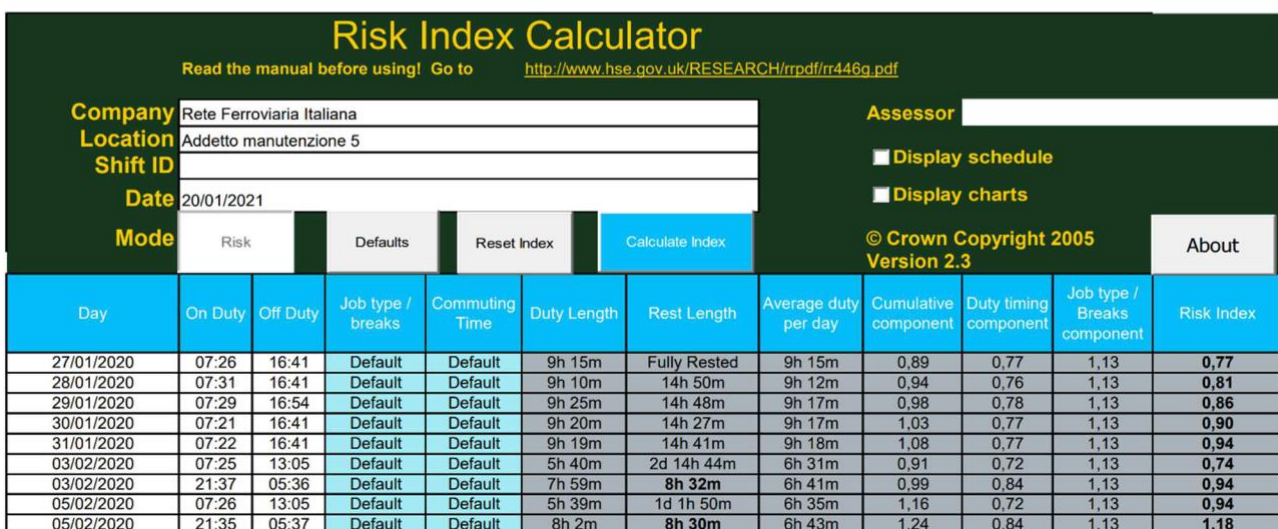
Figure 32 - Fatigue index and risk index for Maintenance Agent 5 (data: RFI - elaboration: DiGIFeMa)

The shifts worked by Maintenance Agent 5 produced a maximum Fatigue Index value of 25.1% and a maximum Risk Index value of 1.18 (Figure 32).

The analysis carried out on the ten days preceding the date of the event shows that, for all the members of the maintenance team, the highest values of the fatigue index and the risk index were reached at the end of the work shift carried out on the night of 5 to 6 February, exceeding, albeit slightly, the average values of fatigue and risk reported above (FI equal to 20.7% and RI equal to 1). In fact, the data provided by the infrastructure manager show that the five maintenance workers had worked a shift on the morning of 5 February (from 7 a.m. to about 1 p.m.) to resume in the evening around 10 p.m. with the night shift, which ended shortly after 5.30 a.m. on 6 February. Evidently this workload resulted in fatigue and a slightly higher than average risk exposure factor, but presumably not such as to compromise the operators' skills and role awareness of the work activities and procedures followed during and especially at the end of the maintenance work carried out.

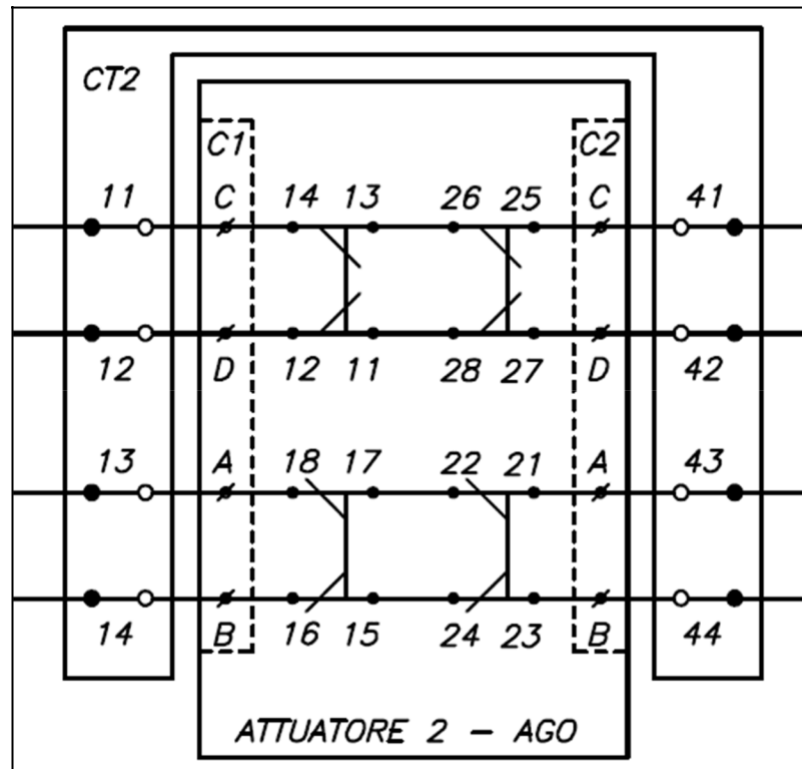
Figure 35 - Needle actuator position control circuit (source: RFI)

For example, in the case of switch actuator 2, the electrical circuit that provides the position is shown in the following picture (*Figure 35*).

In this case, the contact shafts, one for each needle, will establish the following circuit configuration:

in case of normal position:	closing of contacts	13-14, 11-12, 25-26, 27-28
	opening of contacts	17-18, 15-16, 21-22, 23-24
in case of diverted position:	closing of contacts	17-18, 15-16, 21-22, 23-24
	opening of contacts	13-14, 11-12, 25-26, 27-28

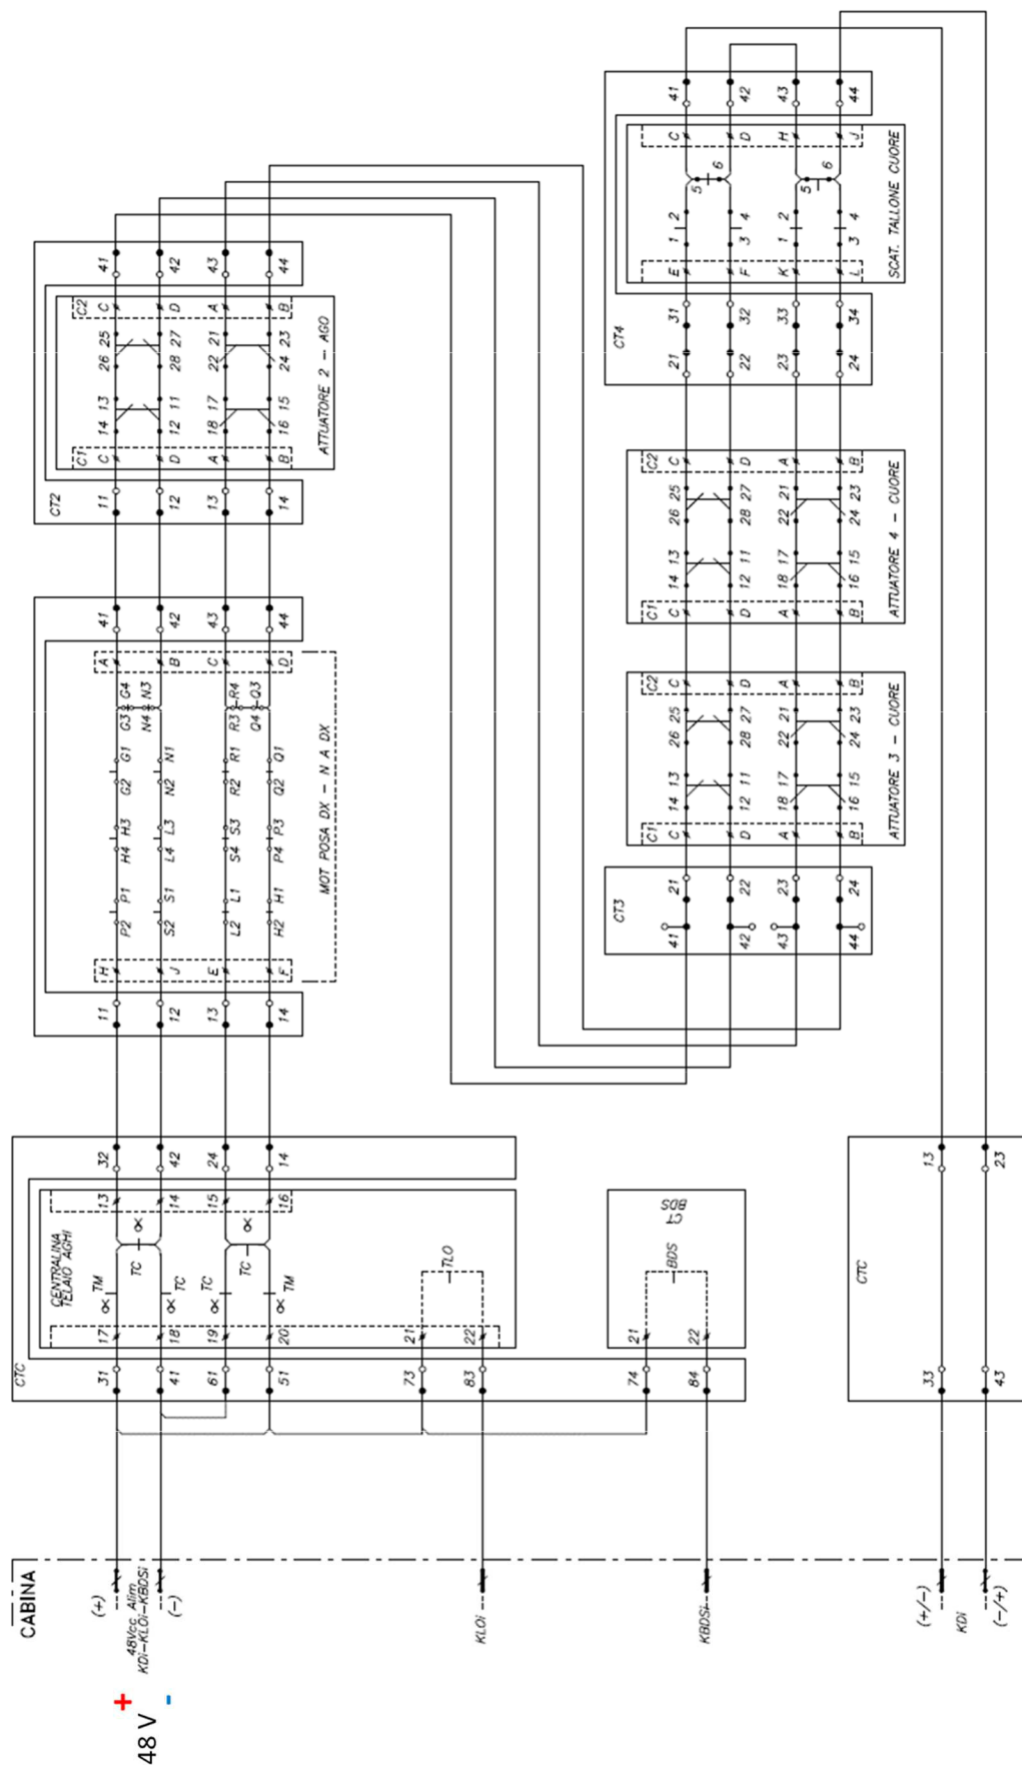
Figure 36 – Switch control circuit (source: RFI)

The switch control circuit, shown in *Figure 36*, has the task of transmitting information from the yard to the cab and to the Central Operations Manager's desk regarding the configuration assumed by the entire switch from the position information provided by the individual actuators. This is achieved by means of a 48V dc powered circuit that connects in series the outputs of the devices described above that provide the position of the individual elements of the switch moved by each actuator, and that returns a voltage to the contacts of the control relay KDi always equal to 48V dc, but with a positive or negative polarity depending on the configuration assumed by the switch. In *Figure 36*, the configuration of the shunter contactor (TM), cascade contactor (TC) and shunter switch contacts is that corresponding to the normal position of the switch. Under these conditions, as shown in *Figure 37*, the voltage at the contacts of the control relay KDi is +48V. On the other hand, at the end of the manoeuvre which takes the switch from the normal position to the diverted position, the configuration of the contacts of the control circuit will be as shown in *Figure 38*, which corresponds to a voltage at the contacts of KDi of -48V.
