General Directorate for Railway and Maritime Accident Investigation

***FINAL REPORT OF INVESTIGATION ON COLLISION BETWEEN M/N "MIKA" AND M/P
"LUGARAIN" RESULTING IN THE SINKING OF THE M/P "LUGARAIN" on 19 OCTOBER 2022
OFF THE COAST OF RAVENNA (EMCIP ref. 2022/018917)***

ROME, 27 November 2023

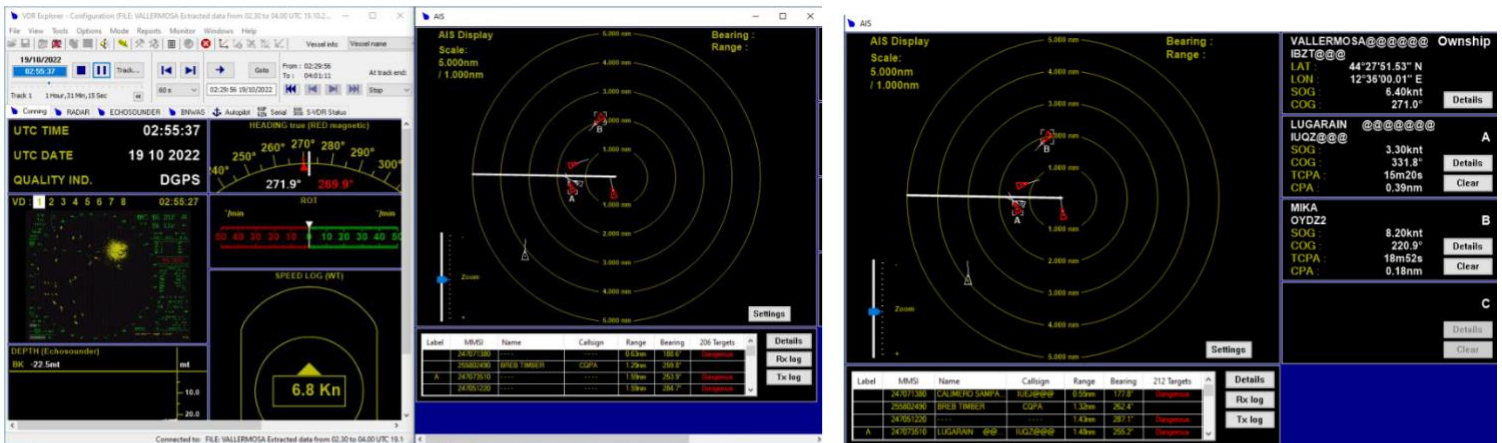
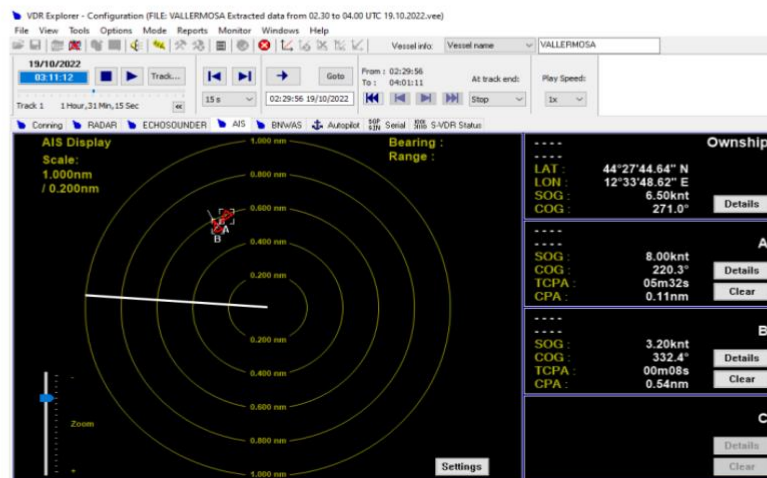
Photo no. 3 – Course and speed M/n “MIKA”

This situation can be clearly seen in the figure below, in which the distance between the point where the M/n “MIKA” was at 04:55 a.m./LT and the point where the collision will occur at 05:10 a.m./LT can be seen. (fig. 3)

COG: 220°

SOG: 8 knt

(the units of measurement remain almost the same from 04:55 a.m. to the time of collision 05:11 a.m.)

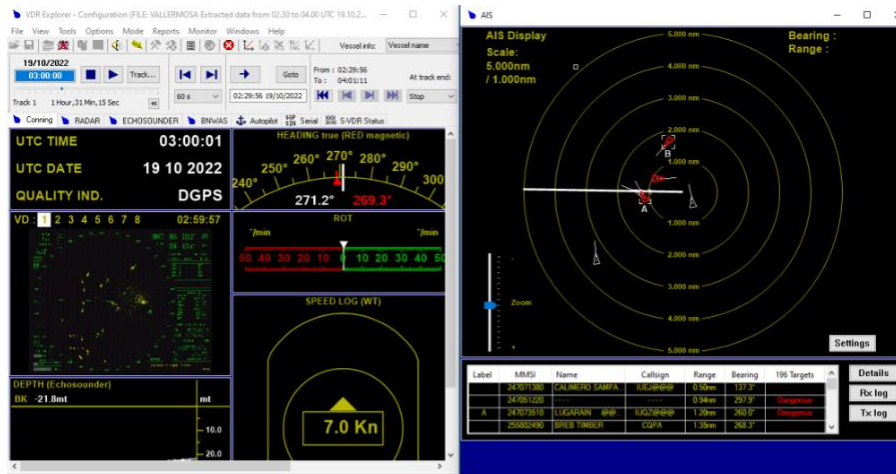
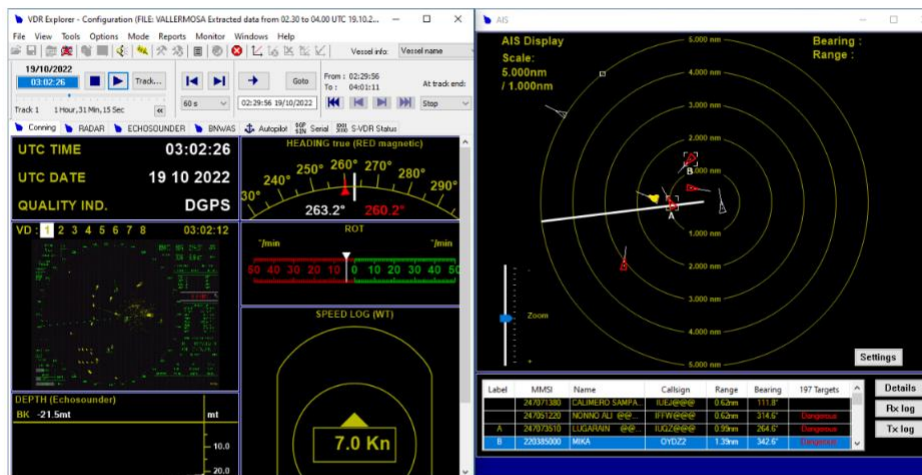
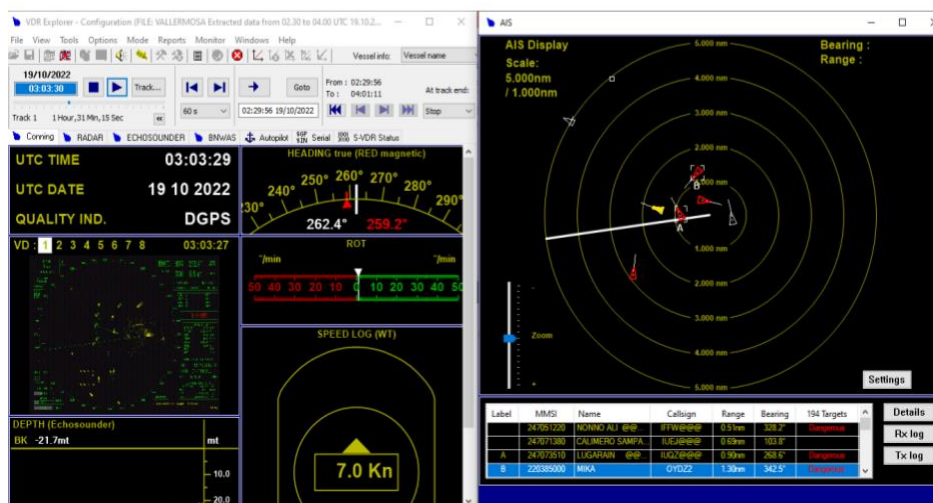
Figure no. 4 - steerage manoeuvres M/c "VALLERMOSA"

ORE 05:01 INIZIO ACCOSTATA A SINISTRA (5° DI BARRA A SX) PER IL VALLERMOSA

ORE 05:03 FINE ACCOSTATA A SINISTRA (BARRA AL CENTRO) PER IL VALLERMOSA

Physical environment: the presence of the M/c “VALLERMOSA” also affects the error of the Captain of the M/p “LUGARAIN” by obstructing the view of the M/n “MIKA” until 05:00 a.m. LT (see Figure 4).

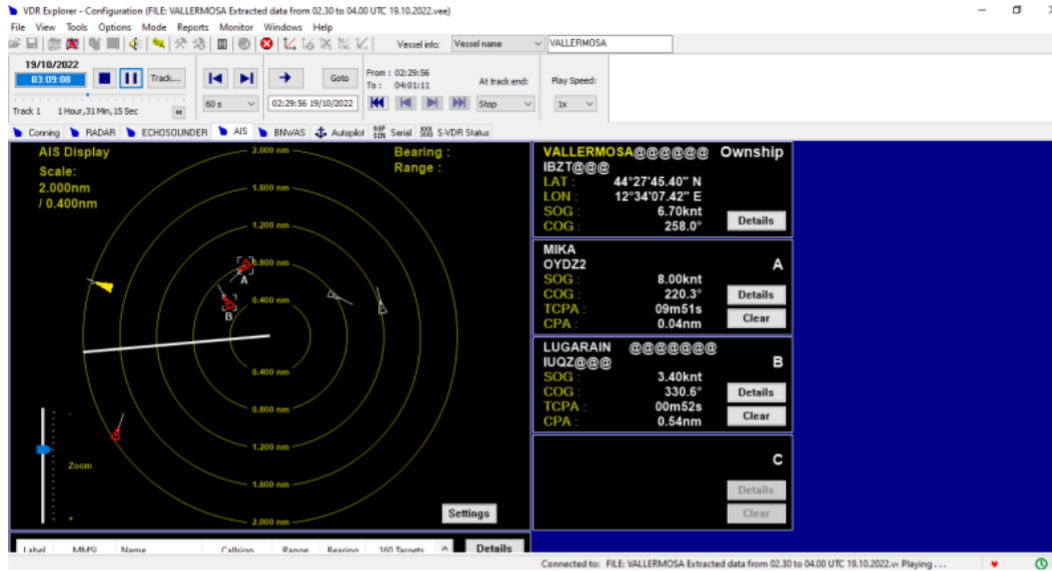
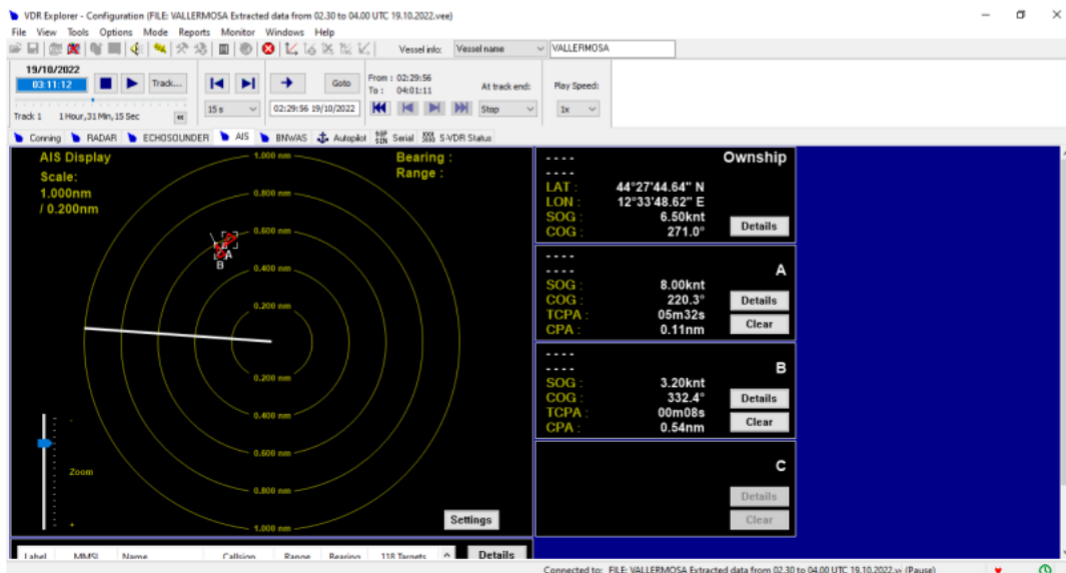
Figure no. 5 – during the collision

ORE 05:09

ORE 05:11 COLLISIONE

The M/n "MIKA" collided on the starboard side of the M/p "LUGARAIN" at 05:10 a.m./LT (03:10 a.m./UTC), in the position with coordinates latitude 44°28',46 N, longitude 012°33',09 E. An examination of the kinematic data collected, the statements made by the two captains and the damage suffered by both vehicles show that:

- the M/n "MIKA" did not suffer any significant damage to the forward submerged part of the vessel;
- the starboard side of the M/p "LUGARAIN" had a gash in the hull that generated a leak and caused it to sink.

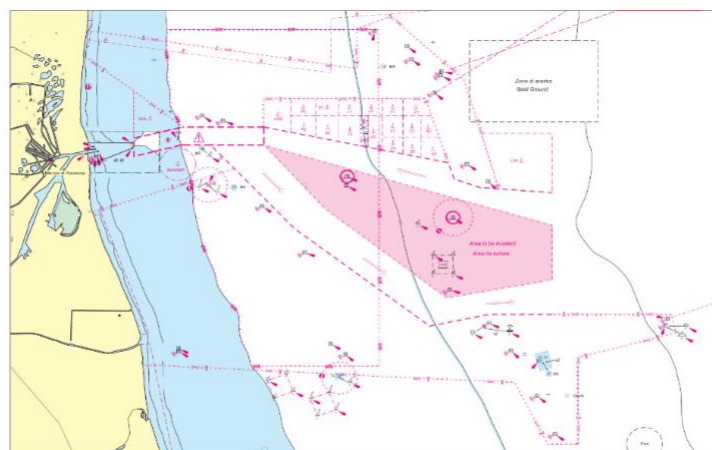
Figure 8 - Ravenna Traffic separation scheme (S.S.T.)

- Violation 2 – The M/n “MIKA” enters the Traffic Separation Scheme in a way that does not comply with the navigation rules. As also highlighted in the report of the Ravenna Harbour Master's Office, the M/n “MIKA” “cuts” the entrance to the Traffic Separation Scheme (see Figure 6).

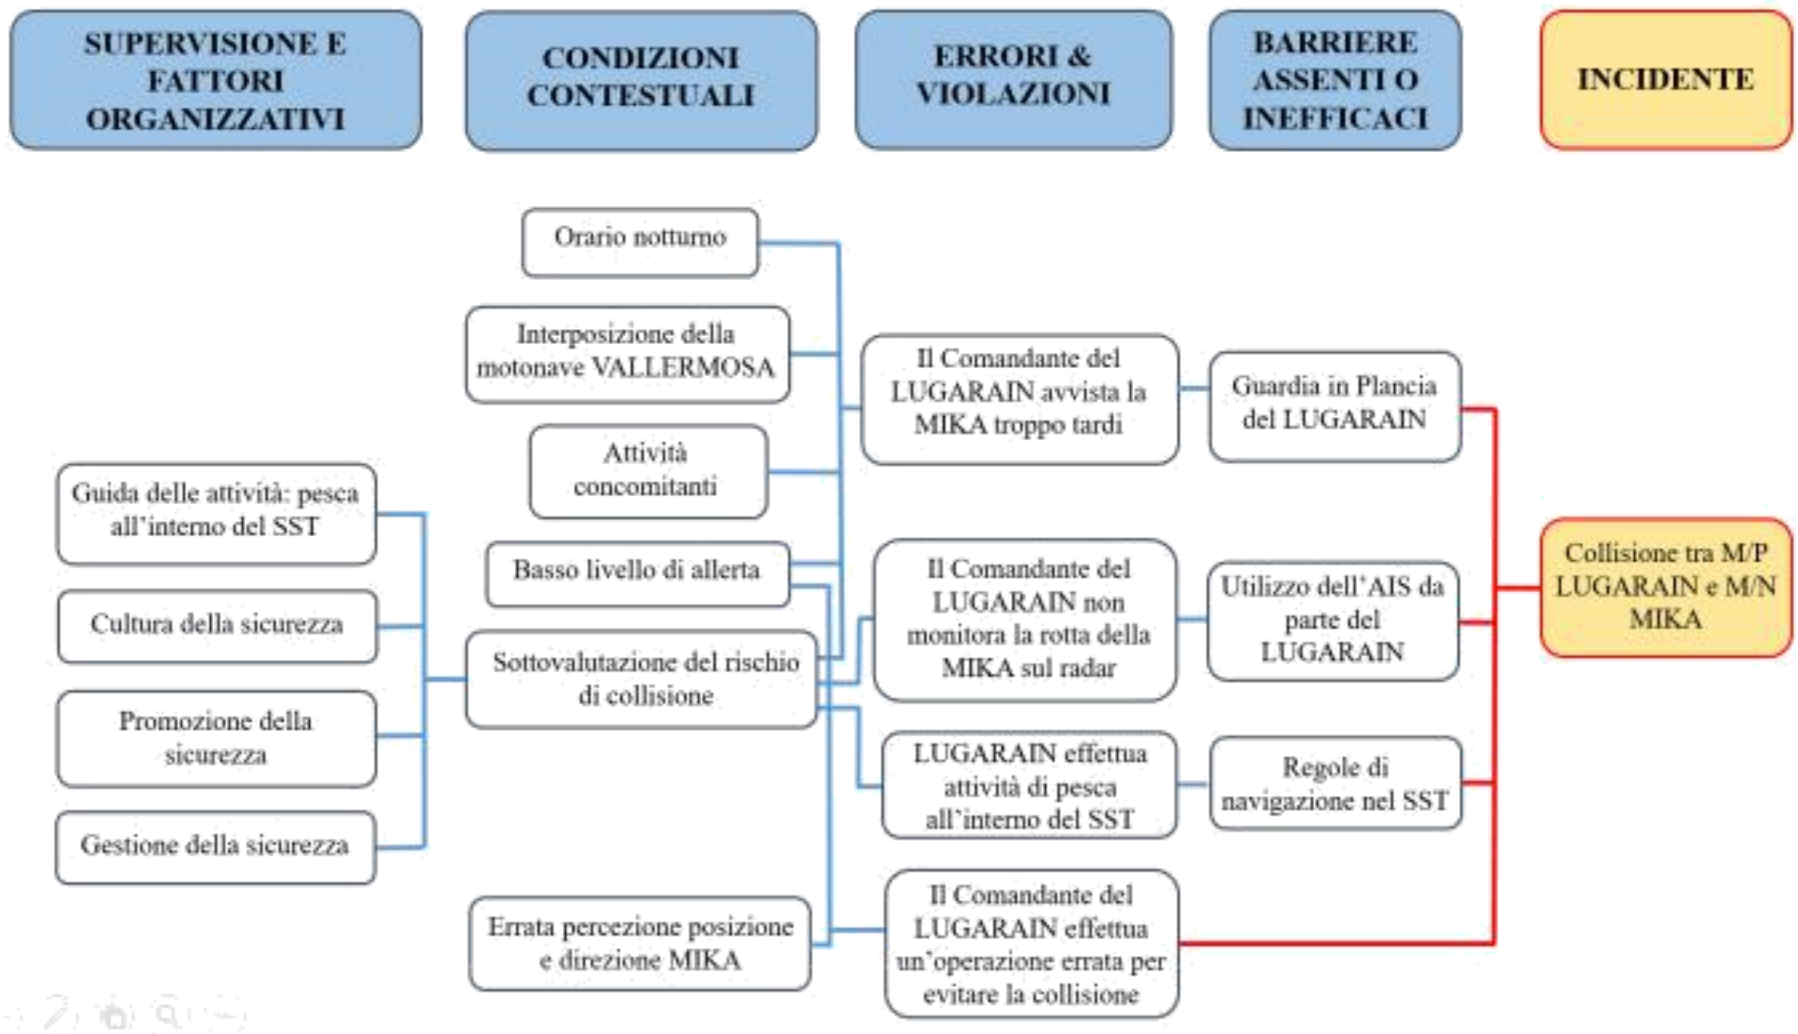
Figure 12: SOAM Collision Diagram – LUGARAIN perspective

The SOAM diagram (figures 12 and 13) summarises all the elements of analysis described above, which have been identified as contributing to or at least enabling the occurrence of the events leading to the accident. Secondly, the diagram facilitates the identification of conceptual and time links between all identified elements at different levels of analysis.
