## FINAL MARINE SAFETY INVESTIGATION REPORT

**VESSEL NAME / IMO No** : SYN ZANIA / 9346938  
**FLAG** : Italy  
**LOCATION OF ACCIDENT** : PETKİM Petrochemical Plant / İzmir  
**DATE OF ACCIDENT** : 01.07.2019 / 23:15 LT  
**CASUALTIES** : 1/-  
**DAMAGE / POLLUTION** : Partial deformation and paint damage on the superstructure and accommodation / No pollution

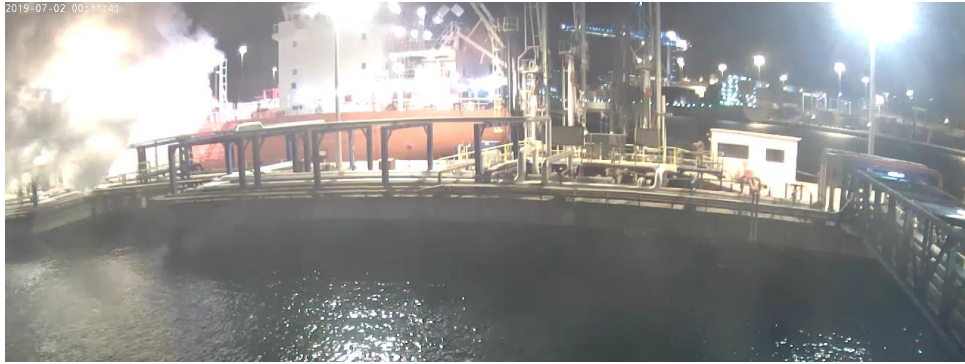
**Figure 11:** Another Snapshot for Leakage (23:11:42)

At 23:05, the pump is activated and it was proceeded to load the cargo in the liquid phase. In the meanwhile, the Loading Master was in his office at Berth 5 and the 1<sup>st</sup> Officer was in the Vessel Loading Control room. Approximately 6 minutes after the initiation of loading with the pump, around 23:11, a sudden gas leak occurred and about 10 seconds later, a massive explosion took place (*Figure 10 – 11 - 12*).

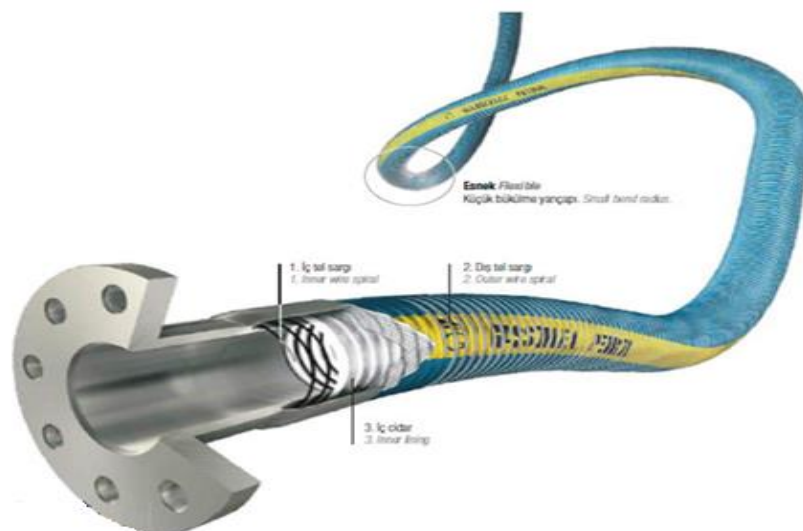
**Figure 25:** Physical Appearance of the Loading-Unloading Hose (Figurative image)

For cargo transfers, Composite Chemical Gasso Flex SST PTFE type hose of 6 inches in diameter and 8 meters in length belong to the terminal was used at the connection between the shore and the tanker. (*Figure 25*)

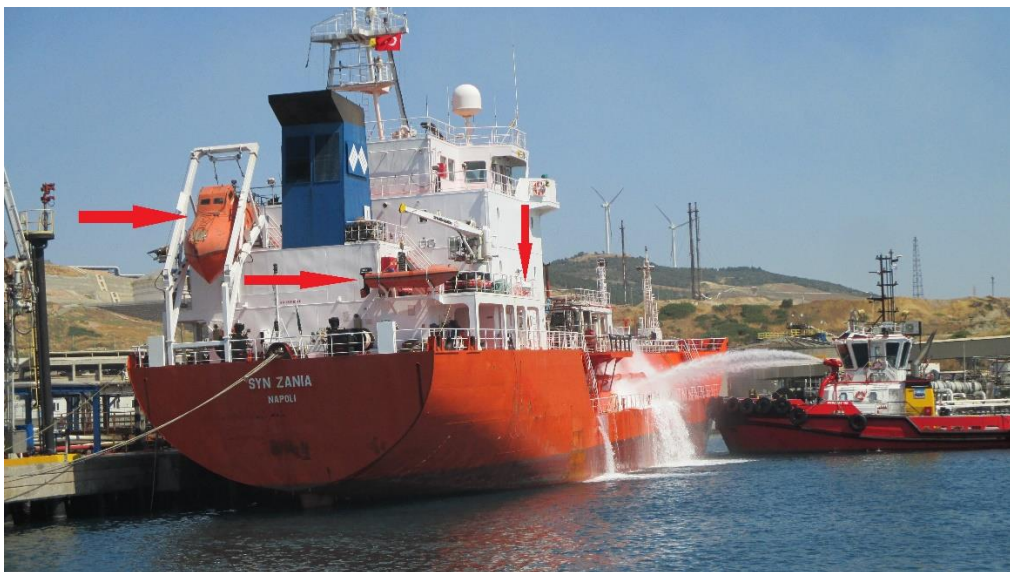
Figure 29: Locations of the Lifeboat, the Rescue Boat and the Life Raft

In the interviews held with the crew, the Master had difficulties in controlling his crew due to panic, caused by explosion and fire and some crew abandoned the vessel by jumping into the sea without taking any order for abandonment. The crew stated that the thermal effect of open flame and fire that was dissipated from the vessel towards the port quarter by the wind prevented the access to the lifeboat floor on the port side, which was the gathering point, and thereby using a lifeboat for abandonment was considered to be unsafe and the strong thermal effect also prevented the rescue boat and inflatable life raft to be used (*Figure 29*).
